Russell Street/Castle Hill Conservation Area

Draft Conservation Area Appraisal

Reading
Borough Council

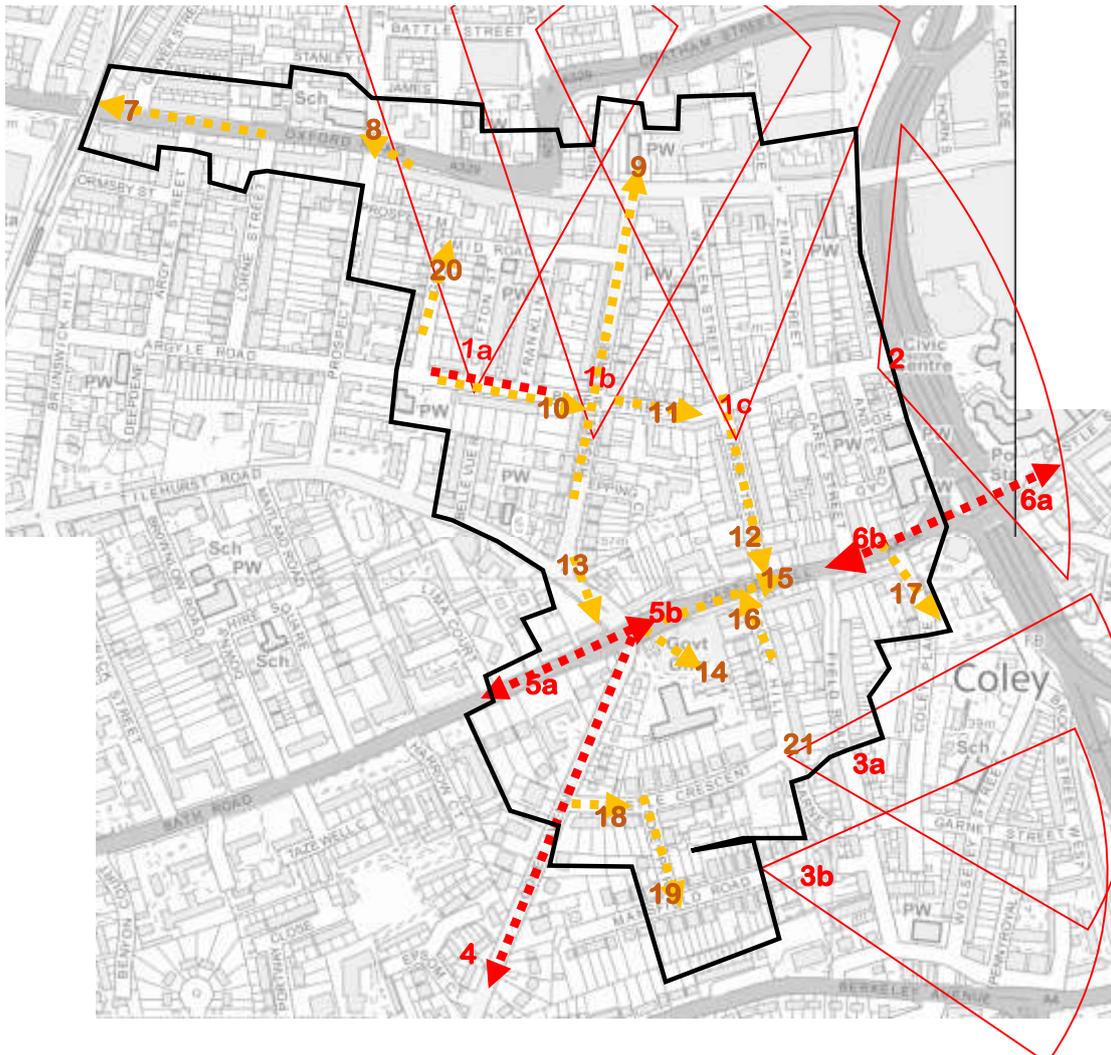
MAP HAS SLIGHT INACCURACIES – 12 MAY 2019
Red outlined cones: Wide views out of conservation area
Yellow arrows: Views within the conservation area
Red arrows: Narrower views in and out of the conservation area

Views form a critical consideration in retaining those qualities about the conservation area that define its character and its specialness. Within Section 6, views relating to each individual character area are defined within that section.

The most important views, both within the area and into and out of it are in each direction along the Castle St/Castle Hill axis, and south-westwards along Coley Avenue. These are shown as views 4, 5a and b and 6 a and b on the views map . They unfold as the viewer travels along the escarpment ridge and follow the curve of the historic route to and from Reading, revealing the area's relationship with the town centre. View 6b (below) progressively reveals the large historic town houses along this route, which are the focal point of the Character Area.

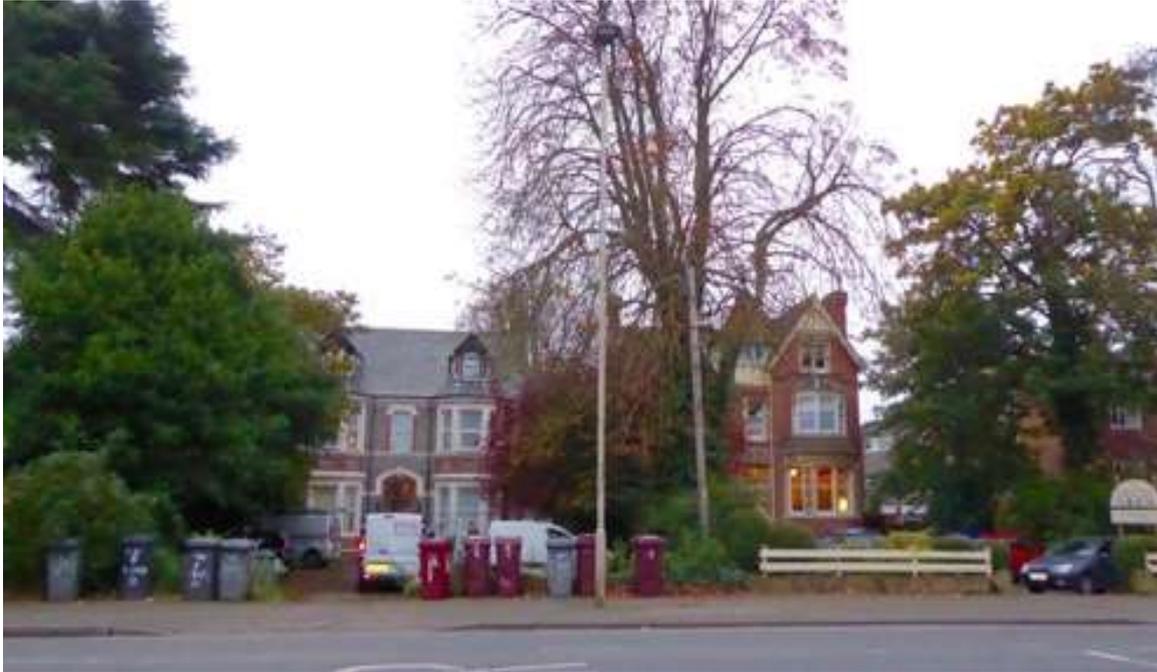
TPO trees in the area

Large TPO trees along the Bath Road

The map above outlines the properties where trees are protected by the Council's Tree Protection Orders (TPO) and also denotes significant street or public domain trees. Not having a TPO does not mean a tree in the conservation area does not merit protection.

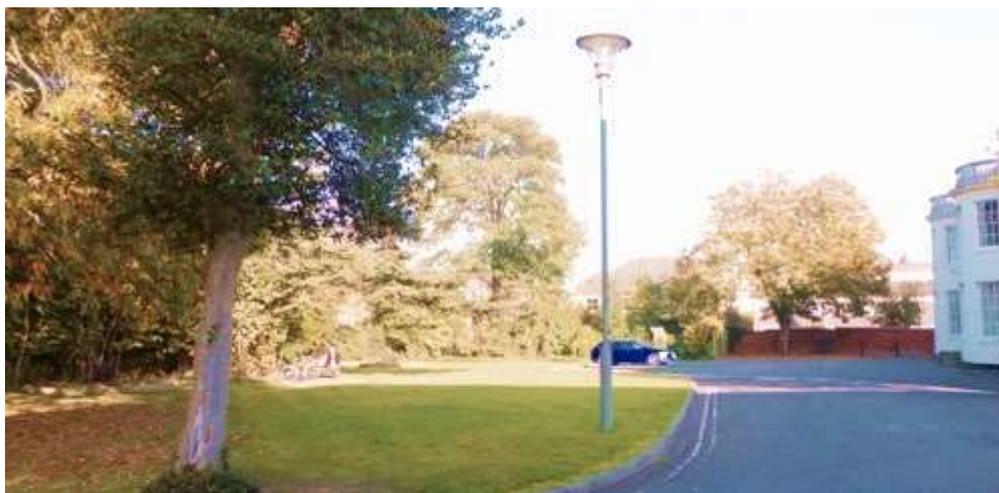
The historical, open front garden space in front of Yeomanry House

The front garden of Yeomanry House is within the curtilage of the site recently sold and being redeveloped into a nursery. This land in front of Yeomanry House was noted in the appraisal in 2004, as forming a much-needed green space for the area that at the time was at least publically accessible, although never an official “public open space.” The garden is important to retain in terms of its historical relationship to Yeomanry House’s original layout.

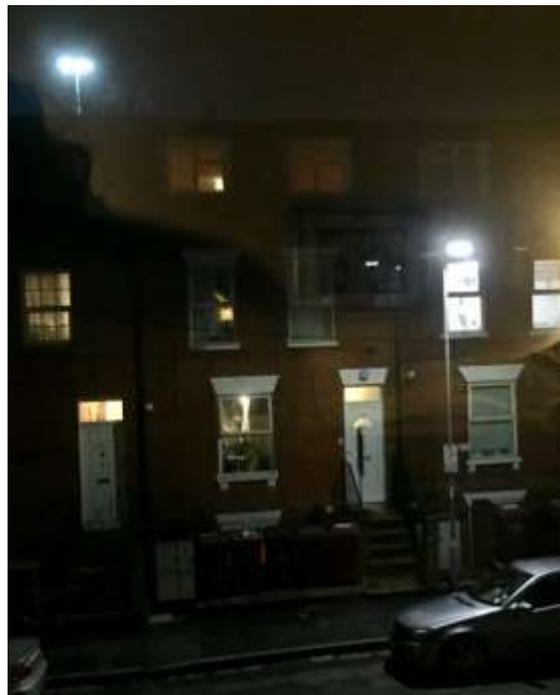
The majority of the lighting in the area is provided by slim silver modern steel columns with simple glass lanterns. Whilst they are not particularly dominant, they are likewise not in keeping with a conservation area setting and as a collection they are overall detrimental to the area. Their lights are very bright and placed at a first-floor level for many of the terraced houses, cause a harsh shine into bedrooms and primary living areas at night.

Lights from the IDR ((above left) and halogen street lights glaring into terraced housing at night along Zinzan Street

The Council has recently undergone a replacement lighting scheme to convert lights in lampposts throughout the town with halogen lighting. This has meant the loss and replacement of many of the old cast iron gas lampposts throughout the town as the costs to convert these lampposts were higher than average. Many of the cast iron lampposts were made originally in Reading's iron foundries. Sadly, the Conservation Area lost all but one on Franklin Street. There is however, early discussion with the CAAC and the Council to try to replace some of the converted ones that were lost throughout the town onto several of the streets within the Conservation Area where there is a particular need of enhanced streetscape amenity.

The scope for improving the street lighting fixtures of the area has wide potential for improvement to the local streetscape.

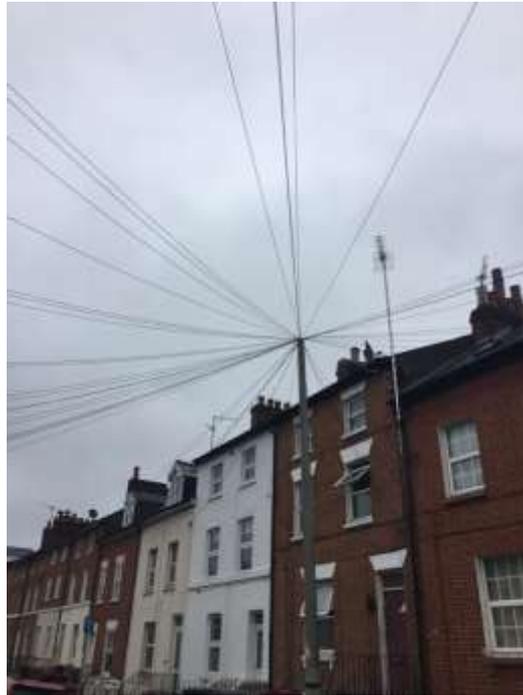
The area relies on the supply of electricity, telephone and internet to be delivered via wires that radiate out from telegraph poles throughout the area. In streets where there are multiple households within properties the wires overhead to properties from the poles causes a substantial visual blight to the streetscape and sky views. A programme to work with suppliers of these services to reduce redundant wires would be welcome.

Overhead wires on a street with numerous HMOs.

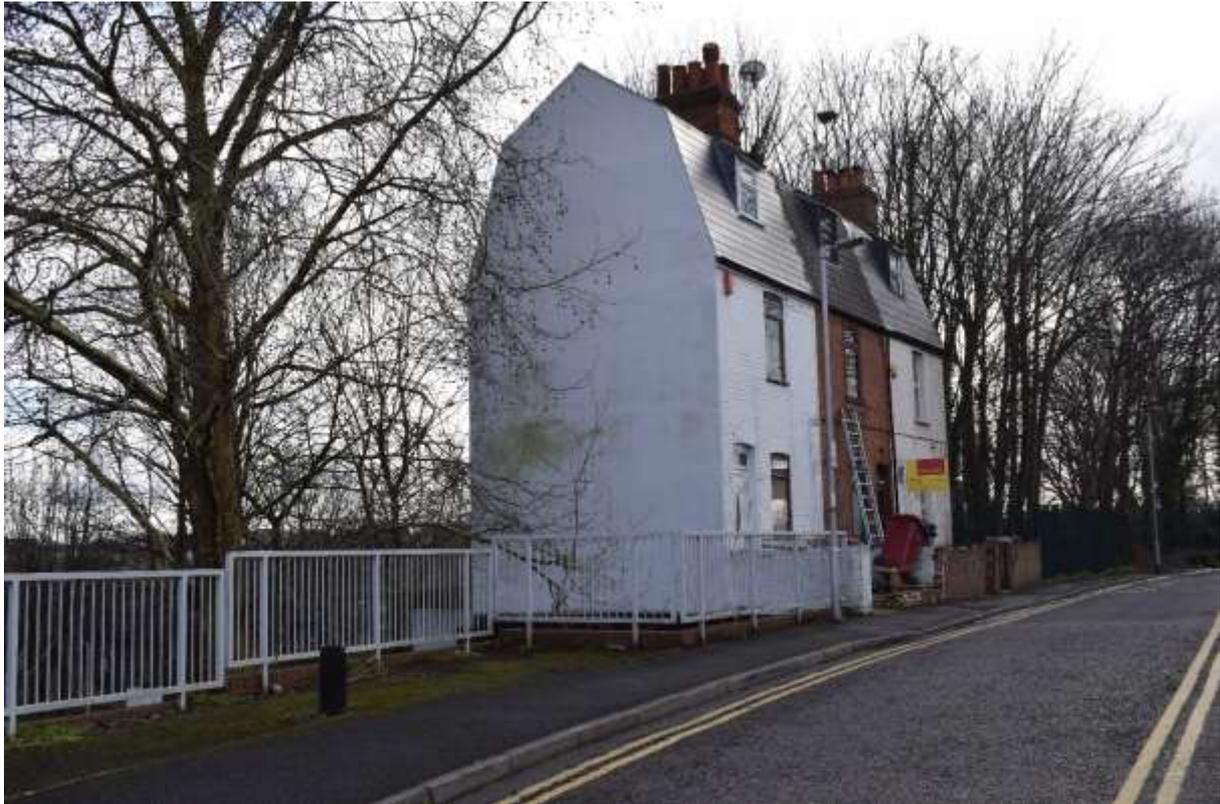
Views off this main axis are also important. View 17 (below), looking southeast up the slight incline of Coley Place, reveals the tall row of terraced houses at 3-7 Coley Place, set against the trees to the rear and contrasting with the grand Georgian houses on Castle Hill. It is a reminder of the larger terrace which once stood off Castle Street on the rise of the land above the Holy Brook.

View 17 Mansard roof terrace along the escarpment. 3 of the original 10 remaining

The small terrace of houses at 3-7 Coley Place perched along the edge of the steep chalk escarpment, are a key element of an important and noted view from Castle Street (view 17). The houses, once part of a longer terrace, are the only surviving examples of early mansard roofs in the Conservation Area and, as such, their simple artisan style contrasts well with the grander houses of Castle Street.

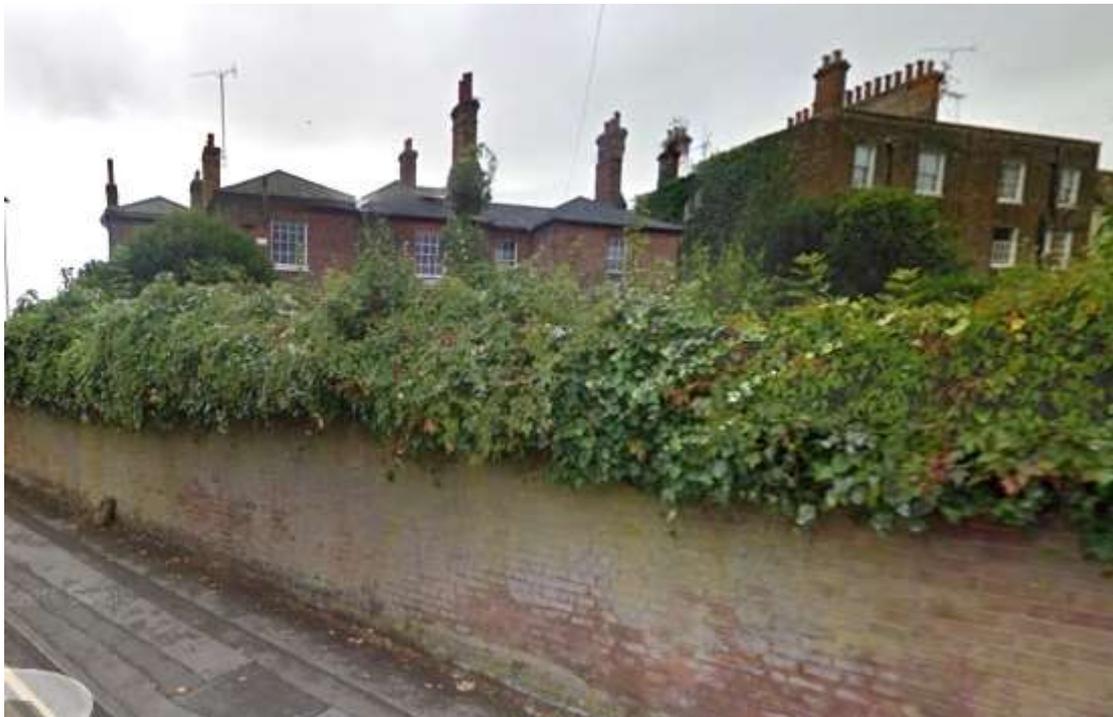
View 13 (below) looks south towards the back of 2 Bath Road, is an attractive view of the impressive tall chimney stacks of 2 and 4 Bath Road. View 14, looking southeast from Coley Avenue into the grounds of Yeomanry House, is of the original house and the modern Berkshire Records Office behind with the property's original gatehouse to the left.

View 13 attractive chimneyscape at the back of 2 and 4 Bath Road

2 Bath Road has a fine Georgian frontage and an attractive chimneyscape, notable at the rear of the site, as seen from the top of Russell Street. Further early 19th century construction near this junction includes Bath Place at 1 Bath Road, which is largely hidden behind a high brick wall. The grand trees (many safeguarded by TPOs) along the Bath Road heading west near the entrances to Janson Court and Lima Court are the only visible reminders of prior demolished mansions. These trees once provided the screening at the back of their large front gardens.

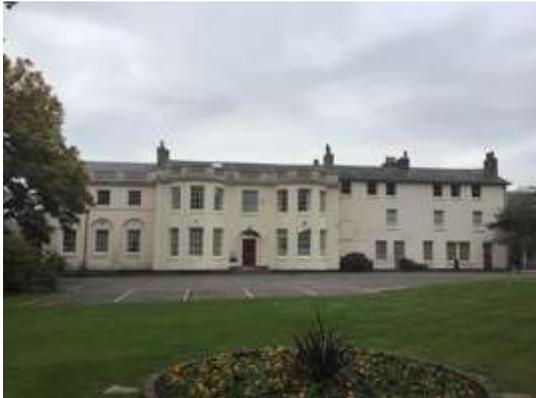
The Grade II listed Yeomanry House (131 and 133 Castle Hill) is the last remaining example of the style of grand houses originally built for the wealthy and prominent businessmen of Reading. It exemplifies the layout of grand houses, with its c.1840 gate house and large front garden facing out onto Castle Hill and its original drive footprint still in situ. The unusual salmon coloured brick of the original part of the gate house is notable for the extent to which this colour brick was used at that time.

**Yeomanry House- house, front drive and garden,
131 Castle Hill**

- Yeomanry House, Castle Hill. Early 19C. Original building 2 storeys, stucco with moulded cornice and stone balustrade. 2 storey circular bay windows. Central recessed entry with wide fanlight. Slate roof. Unfortunate later 19C extension wing to right.

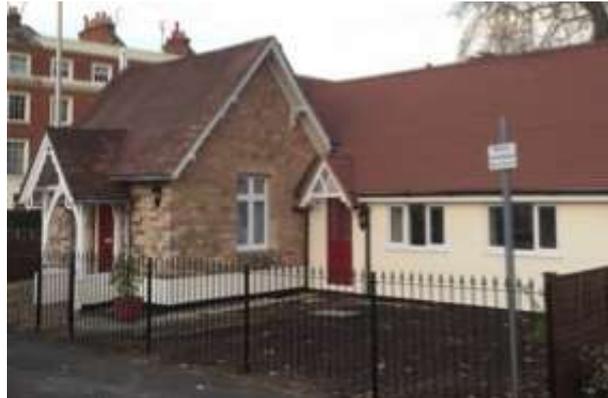
**Former c.1840s gate house for Yeomanry House,
133 Castle Hill**

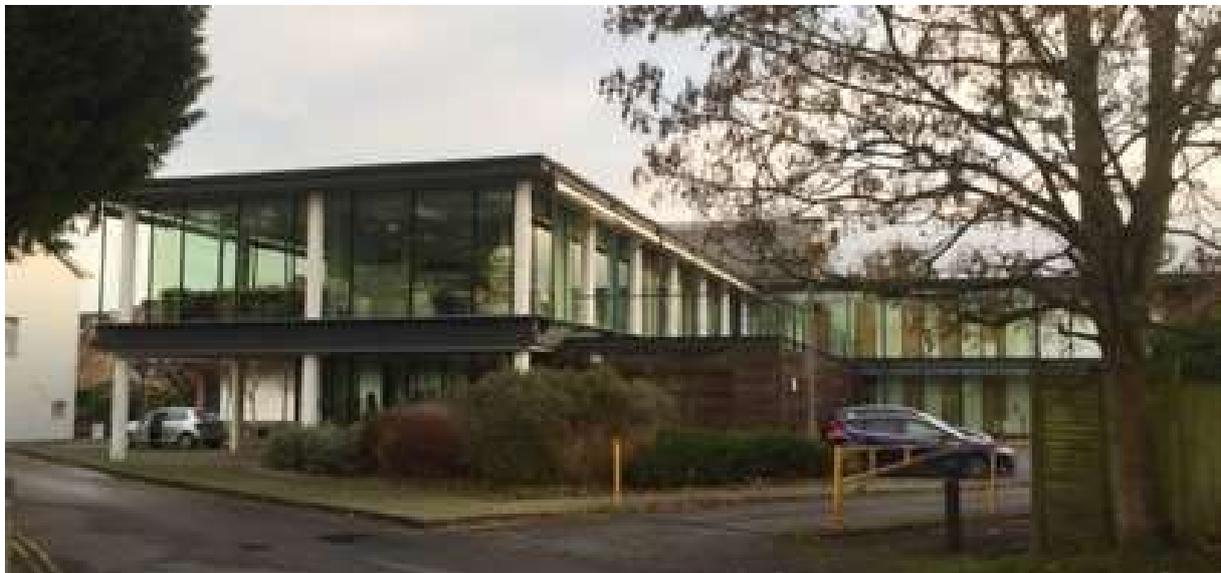
The modern, purpose-built Berkshire Record Office was built on the site of the former riding arena and stables. The attractive design of its façade, massing and footprint sets it back from the historic house and its front gardens.

Berkshire Record Office, on the Yeomanry House site

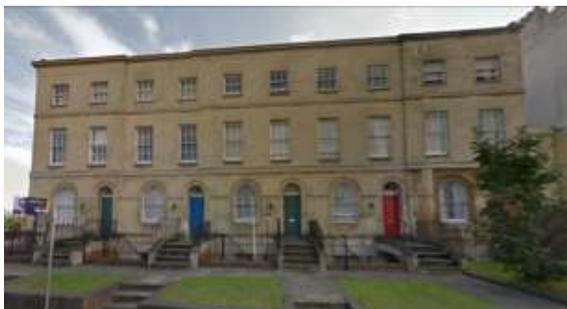
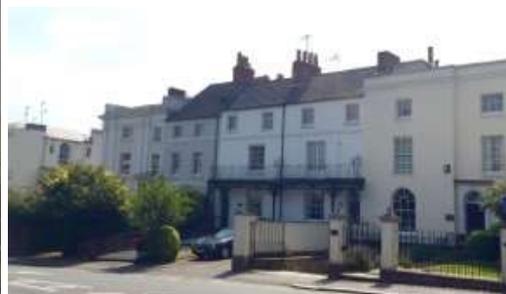
The early 19th century Bath stone Blenheim Terrace, at 97-105 Castle Street, is impressive and attractive. The houses at 97-103 are generally well-maintained but 105 is in multiple occupancy and is in a poor state of repair. The terrace represents one of only two major uses of Bath stone within the conservation area.

The fine group of houses from 113-121 are substantial Georgian homes, each contributing to the architectural variety within the terrace. The terrace is attractive because of this variety, despite the negative dropped kerbs to most of the fronts. 113 forms a particularly striking end of terrace property, with rusticated paired and channelled pilaster strips, topped with wreaths.

**Blenheim Terrace, Bath stone terrace, Attractive diverse terrace of Georgian
97-105 Castle Street properties, 113-121 Castle Street**

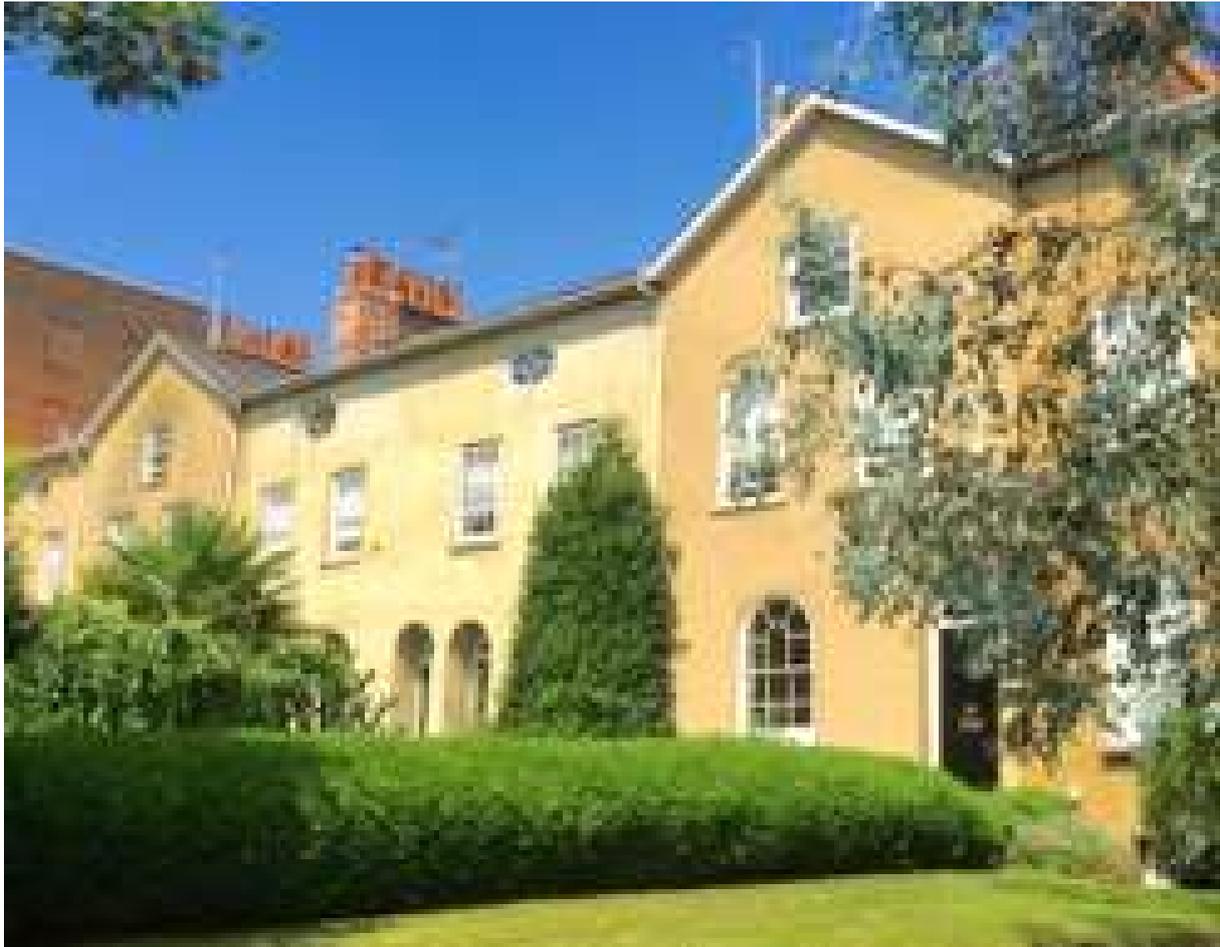
Bath stone coloured stuccoed Regency style terrace, 134- 144 Castle Hill

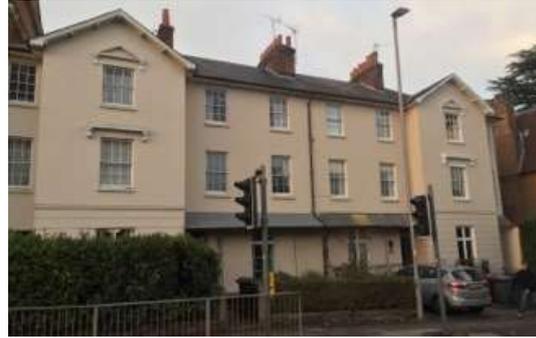
The Jesse family were local developers and had great interest in the surrounding area. The family resided at the former King's Arms Inn at 154-160 Castle Hill, associated with late 17th century beginnings from circa 1800 to circa 1900. Their hand in housing development developed a particular style, displayed in a number of the properties along the route, notably at Heritage Court (144A – 152) and at 162A- 166. The attractive verandas with concave metal roofs and Regency style metal work distinguish their developments in the area.

Jesse family developed terrace with Regency iron detailing, , 162-168 Castle Hill

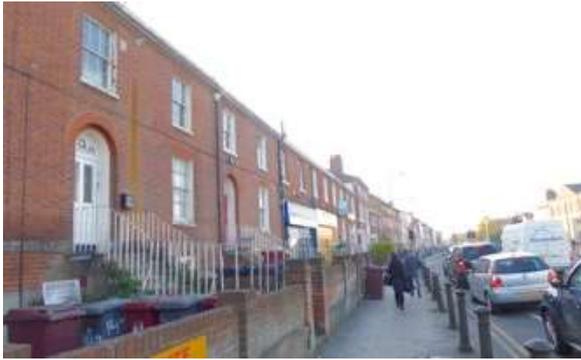
Most of the early residential terraces are in moderate to poor condition, with several converted to shops at ground floor level. The Georgian terraces are largely of red brick, except for the impressive stuccoed villas at nos. 197-203. Fortunately, a majority of the listed terraces still retain original windows, doors and detailing. Some of the original brick walls in front of these properties, notably at nos. 149-153, need repair and re-pointing.

Run-down Georgian terrace at 149-177 Oxford Road

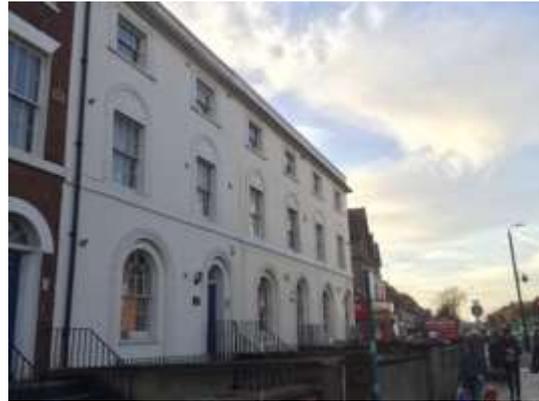
Grand stuccoed Georgian Sidney Terrace at 197-203 Oxford Road

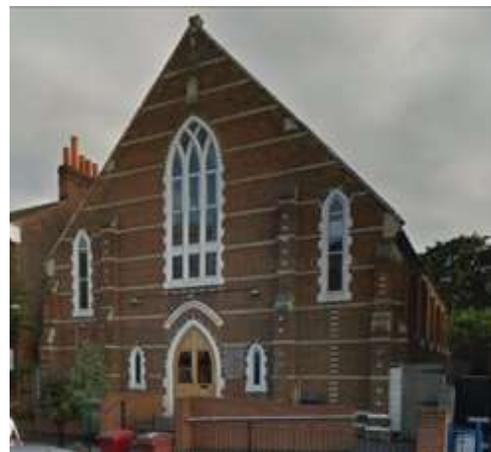
Providence Chapel c 1859, 103 Oxford Road (Google Maps)

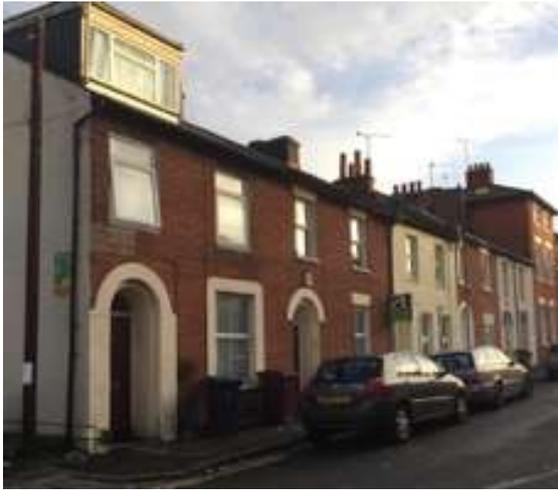
1-9 Prospect Street, modest Georgian artisan terrace in poor condition

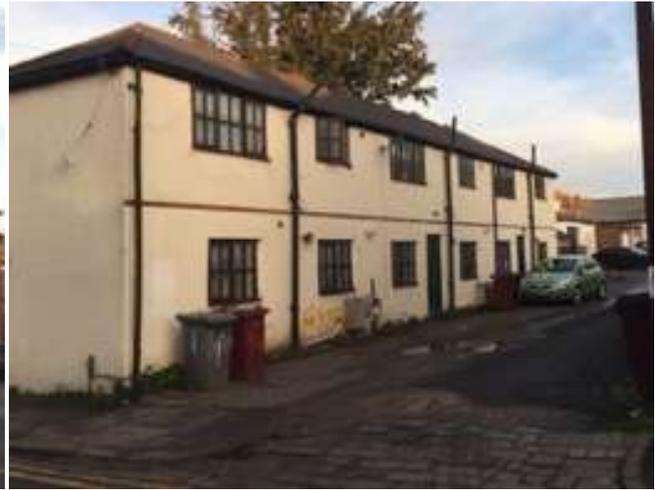
The development along the east side of Prospect Street from the Oxford Road up to Baker Street, consists of small late Georgian artisan terrace, nos. 1-9, built prior to 1833. The terrace collectively is in poor to fair condition. Along with Prospect Mews, to the north, built prior to 1853, which is in fair condition, these properties exemplify the homes of a many of Reading's residents during the early part of the 19th century. Two of the houses, 5 and 9 Prospect Street, are stuccoed like Prospect Mews. The house at 9 Prospect Street, has the original fanlight and windows, along with many original interior features and is still in use as a family residence. A representative expanse of stone paving has been retained at the entrance into Prospect Mews.

Prospect Mews, mews houses with an expanse of stone pavement at the entrance to the alleyway

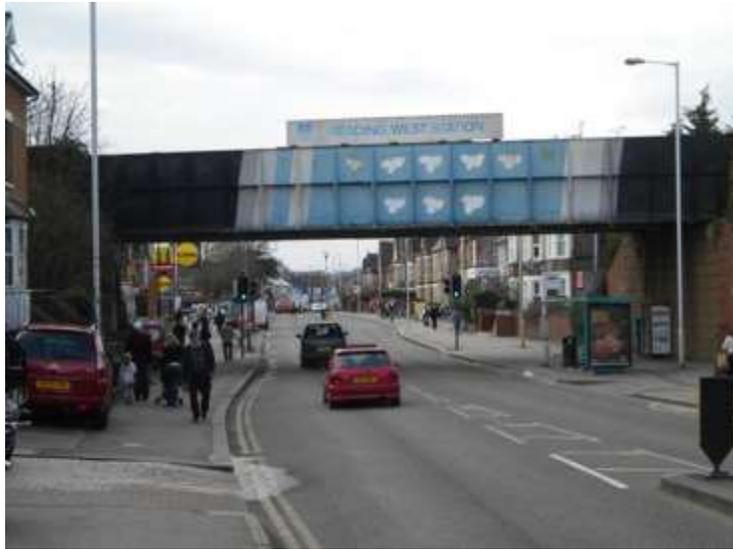
The railway bridge is a prominent reminder of Reading's progress and industry in the mid 19th century. The Reading West Railway station is being modernised, which could substantially improve the area and the appearance of the bridge if it were either repainted or re-built to reflect its original brickwork and architectural quality.

Reading West railway bridge, Oxford Road

- Poorly kept front retail spaces extending to the pavements detracting from the traditional street line
- The poor condition of the railway bridge over the Oxford Road

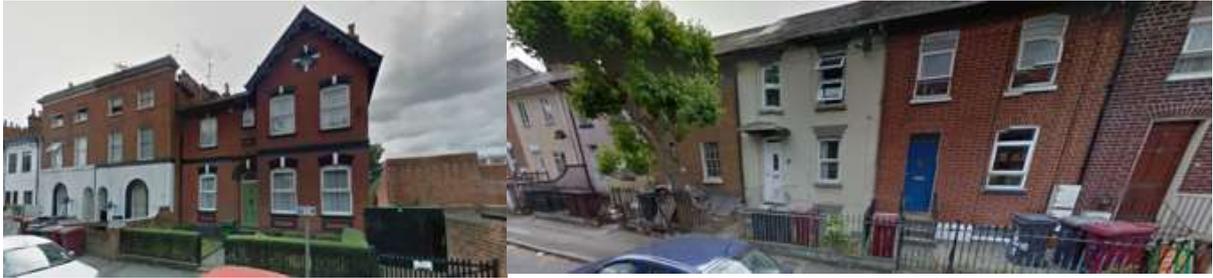
The original properties on the western side of Howard Street have been retained; the houses along the eastern half were demolished for the creation of the IDR in the 1960s. 4-4A Howard Street is a listed Georgian semi-detached pair of houses; the original stuccoed rustication on the ground floor of 4A has been retained. 2 Howard Street dates from c.1850-70s, and is an attractive and well-kept, family home of substantial size with a well-tended front garden. There are a number of original front garden cast iron railings at 16-22 and two original curved stucco dividing walls at 4 and 22 (see fig XX). The rendered façade at 8 and the irregular colours and over-painting of many of the houses are incompatible with the otherwise red brick simplicity of the rest of the houses, creating a sense of disharmony along the street. The line of trees minimises the sight and noise of the IDR and provide reasonable tree coverage in the summer but afford less coverage in winter. Recently re-painted, black cast-iron bollards line the street in front of the trees.

2, 4 and 4A (listed Georgian semi-detached) Howard Street showing the rustication on 4A (Google Maps)

- 4 and 4A Howard Street. 3 storey pair of houses, early 19C. Red brick, rendered parapet and ground floor, one with original rusticated stucco. Arched entrance doors and ground floor windows.

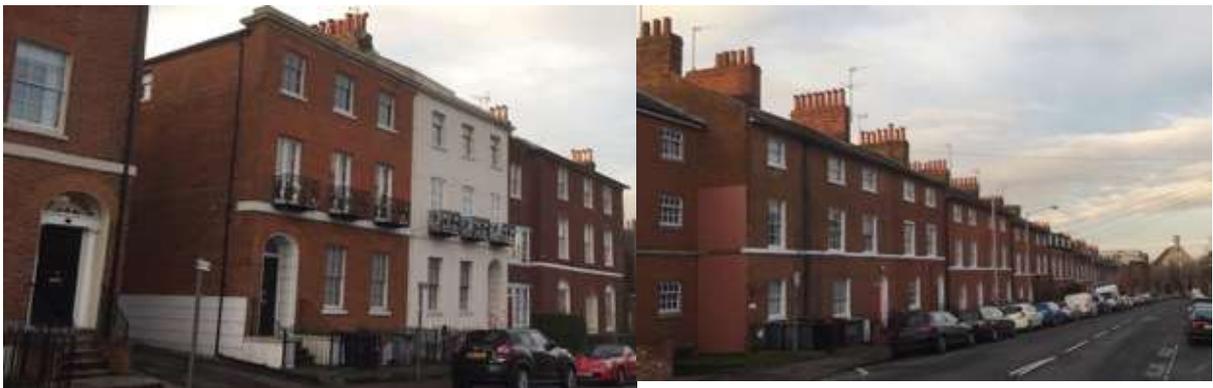
Terraces along the west side of Russell Street (nos. 38-42) with Regency window balconies

Georgian terraces along the west side towards Oxford Road with the Holy Trinity parish church at the end

- 40 and 42 Russell Street. Early-mid 19C pair of houses, 3 storeys and basement, red brick with stucco cornice and shallow pediment. No 40 has been recently and poorly rendered. Arched doorways with rusticated stucco recess. Elegant first floor cast iron railings.

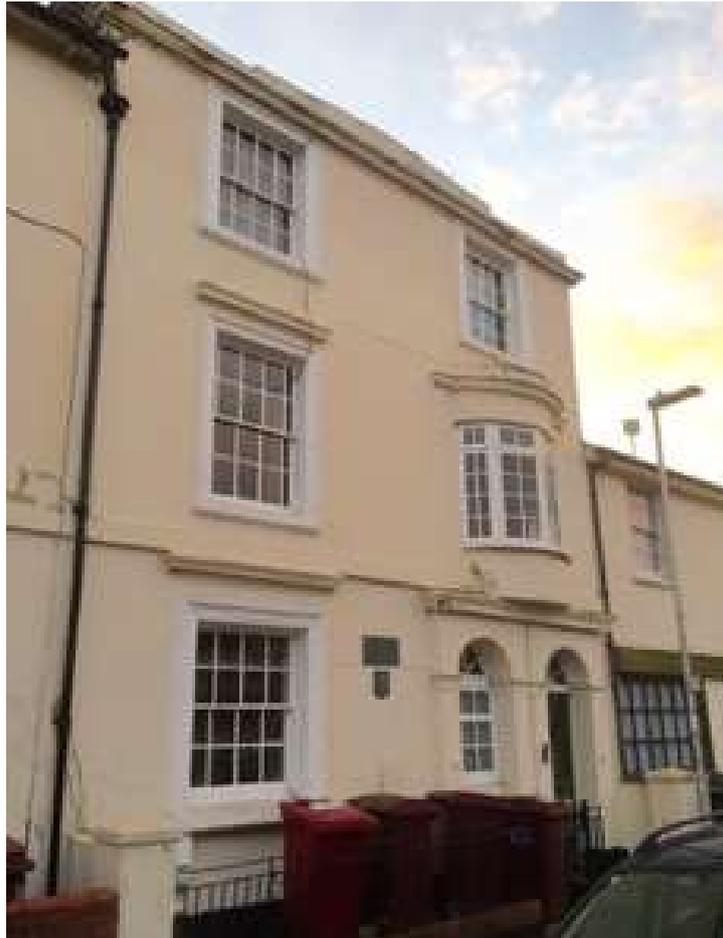
The stuccoed, late-Georgian terrace at 37- 55 Baker Street built prior to 1833 are the oldest houses on the eastern part of that street along a portion of the street originally named Russell Terrace. Their poor condition belies their historical significance; the pioneer of early photography, Henry Fox Talbot had his 'Reading Establishment' studio at 55 Baker Street.

Fox Talbot's 'Reading Establishment' studio at 55 Baker Street.

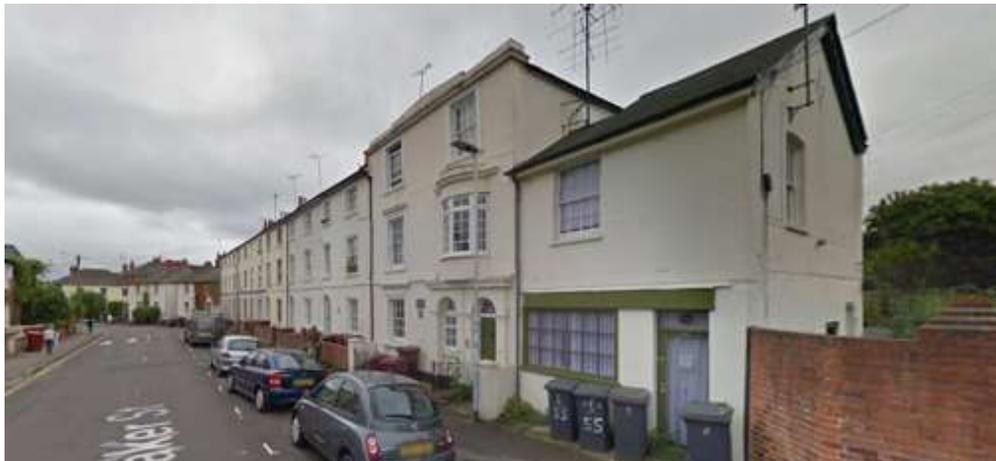
A mirrored pair of two-storey, semi-detached houses, with side doors are at 33-35 and are listed.

The earliest set of houses on Baker Street from 33-35 (listed) and no. 55 Henry Fox Talbot's studio at the near end

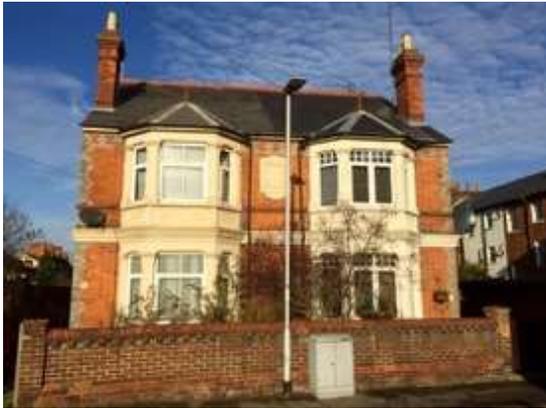
Other buildings of note along Baker Street include the semi-detached Rednirt Villas, which are notable for their attractive stonework, and date from 1904.

Rednirt Villas 1904, developed by Mr. Trinder, bay windows, polychrome and stone work detailing

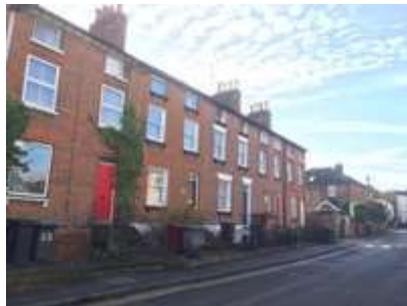
23-31 Alexandra Terrace is a simple, red brick terrace with many original windows and details intact and dates from prior to c.1853; the property at 23 is in poor condition and 31 has seen a recent loss of its original windows.

23- 31 Baker Street, Alexandra Terrace, c.1850-1870, red brick terrace, overall well-preserved with majority of original windows and doors intact

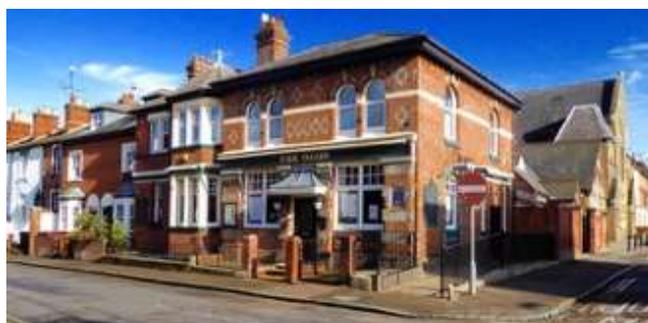
The Oasis Community Centre dates from c.1850-1860s. It was a public house, inn and spirits retailer's warehouse in the late 1800s. A small area of surviving sett stones are located on the pavement in front of the original cast iron door opening for loading the cellar. Now well-restored and maintained by the Carey Baptist Church, it serves as a current asset to the local community. The remains of an advertising sign from the last decades of the 1800s proclaiming "Ferguson's Pale Ale, Stouts & Porter, Wine & Spirits" is located upstairs, along a brick wall that formed the exterior wall of the original building. The sign is currently covered by plasterboard.

The Oasis Community Centre, c.1850s Inn and Public House

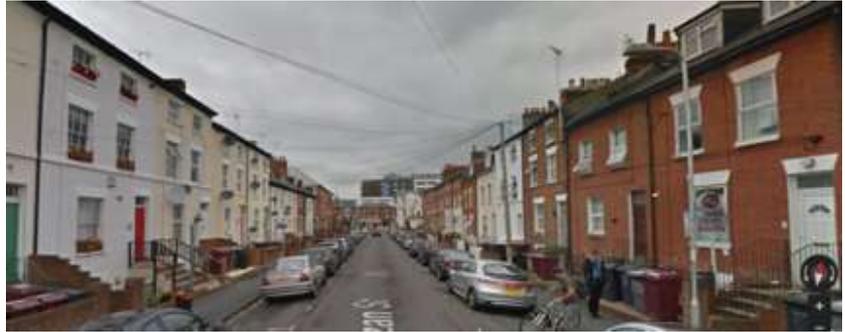
The poor conditions of the terraced housing along Zinzan Street with overhead wires, bins and satellite dishes. 26 Zinzan Street (to the left) is the only house with original windows still intact

Like Zinzan Street, piecemeal replacement of original features with modern materials has adversely affected houses on Carey Street. Original windows have been retained in houses at no. 13, and the upper floors of no. 15. Original cast iron railings remain at nos. 13 and 25. Chimneys and pots largely remain on the east side of the street, but the west side of the street has fewer and is an almost continuous run of over-painted brick façades. The Carey Baptist Church has an impressive polychrome frontage, is well maintained and provides a visual highlight on the street. Some interior details remain inside its main worship hall. The view to the backs of the large Georgian houses that front Castle Hill and the tall brick dividing wall along Carey Street is one of the more striking views from the street. The modern building at Wolford Hall that houses the Reading Association for the Blind is incompatible with the historic built environment of the area.

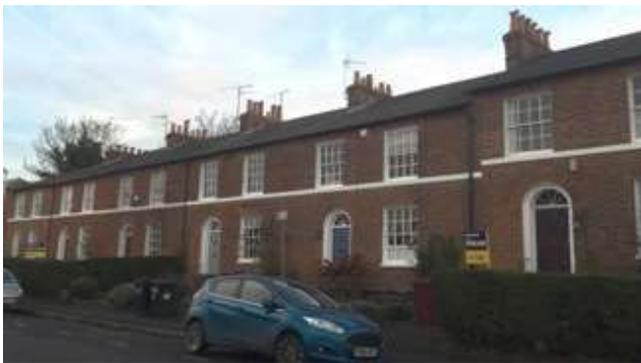
The Georgian terrace of houses at 61-79 Baker Street were the first buildings constructed in the 1820s. The features of the terrace are notable, with retention of original windows and doors. The iron railings at no. 69 were recast from the original arrowhead railings that once existed along the terrace.

The listed Georgian terraced houses from 61-79 Baker Street, complete with original doors and windows

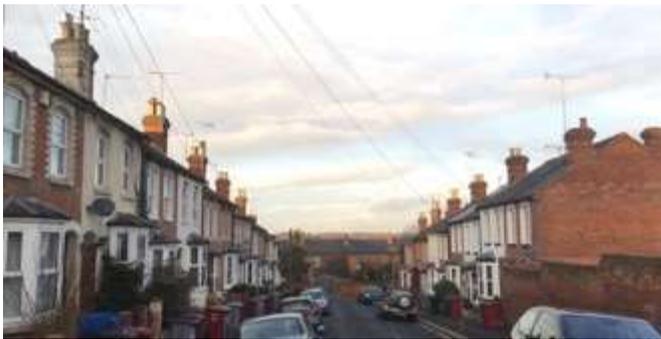
The short, quiet cul-de-sac of Belle Vue Road, was created by the 1890's from the side garden of Bellevue Villa. Belle Vue Road is associated with two-up, two-down, terraced polychrome houses creating a harmonious effect along both sides of the road. Regrettably, some of the façades have been painted, disrupting the once continuous polychrome detailing along the street. However, original windows have been retained on several properties and the doorways have attractive stone-arched porches. There is still a fine high wall down the east side of Belle Vue Road separating the Villa from the development. At the far end of Belle Vue Road, the modern tarmac road surface has eroded to reveal several square metres of the original cobbles or sett stones, which were laid in a traditional fan pattern.

Belle Vue Road, (c.1880-90) small polychrome terrace with high wall separating the development from the original Bellevue Villa

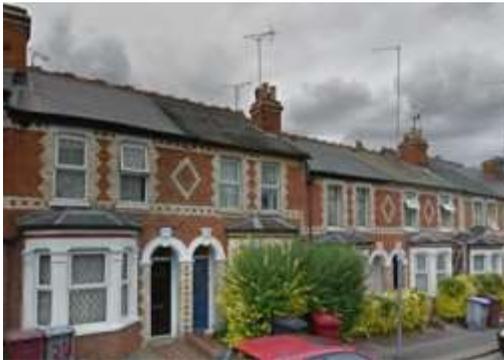
Terraced housing on Franklin Street with the diamond shape polychrome designs between the houses

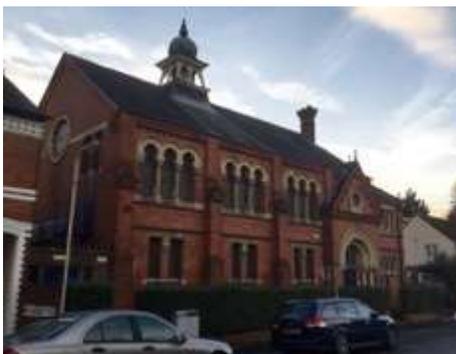
Reading Synagogue in Goldsmid Road is listed in recognition of its significance and high quality. It dates from 1900 and is a fine expression of Moorish design in polychrome brickwork and stone, topped with a wood and lead cupola. Whilst the original synagogue is one the Conservation Area's finest buildings, the modern Sr Herman Gollancz Hall attached to the original building, facing Clifton Street is out-of-keeping stylistically, and if redevelopment were to take place on the site, a building more respectful of the impressive structure that it is attached to would be advised.

Listed Moorish style synagogue with brick and stone detailing and imaginative bell tower

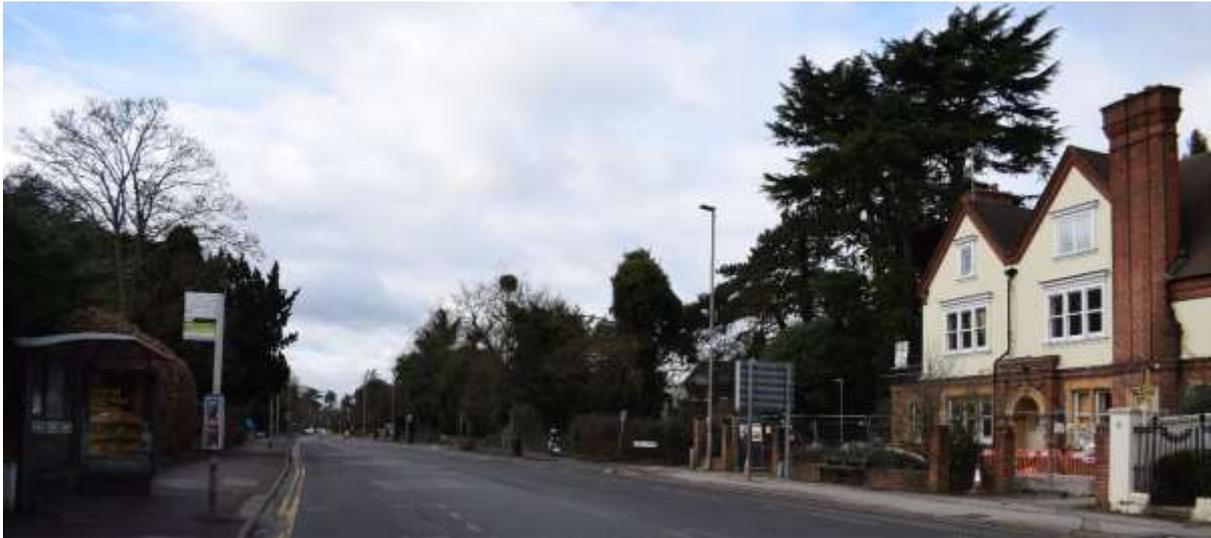
View 5a looks west along the Bath Road towards the Downshire Square Conservation Area from the junction of Castle Hill, Russell Street, Coley Avenue and Bath Road. The view of Downshire Square Conservation Area is screened by the largest collection of fine, mature trees within the Conservation Area. Twenty of these mature trees are protected by TPO status.

Looking west along the Bath Road (view 5a)

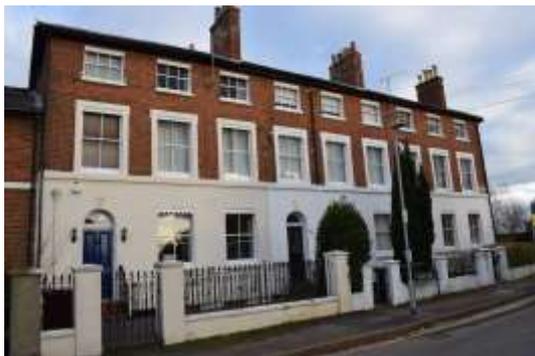
Coley Hill dates to circa 1820s, with a fine varied Georgian terrace along the east side of the street. There are several terraced groups of 2-3 storey listed houses, predominantly in brick, though some have rendered stucco façades. Many of the houses have original railings, arched Georgian windows and original doors, that strengthen the visual strength of the east side of the street. The preservation of these details is becoming more challenging as HMO use along the street is becoming more common. A lone, modern, well-kept two-storey detached house in the middle of the Georgian terraces is incompatible and disrupts the harmony along the east side of the street. The modern infill along the west side is quite incongruous with the Georgian side, and more sensitive re-development of the west side in the future could significantly improve the overall character of the street.

31-35 Coley Hill Georgian terrace. 1820-30s

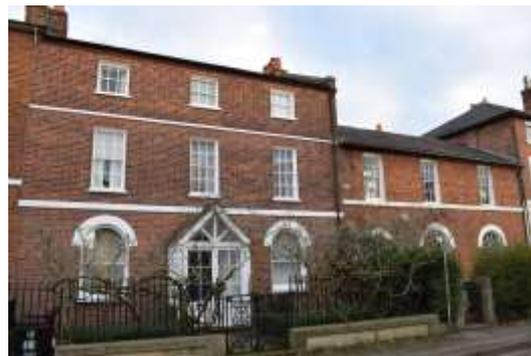
Arched windows and fanlights on Georgian houses, Coley Hill

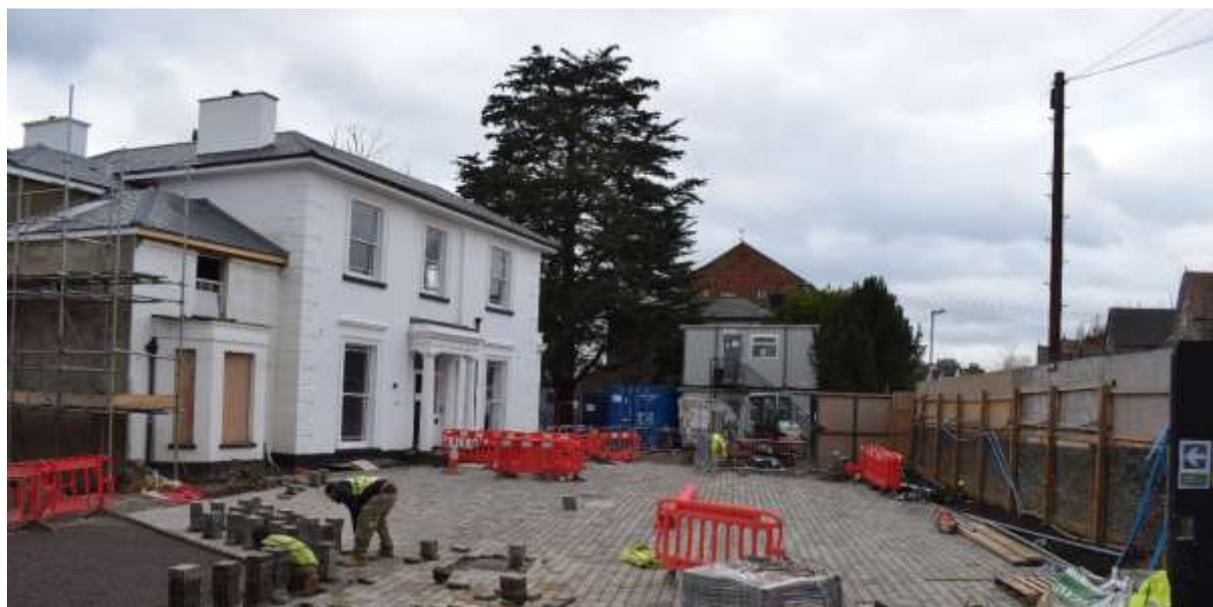
3 Castle Crescent c. 1840, in process of restoration

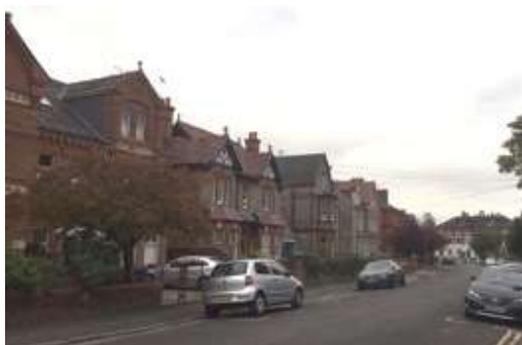
The properties on Castle Crescent and Mansfield Road date from c. 1880-1900, and are noted for their impressive grouping of large, late Victorian villas, each detailed with polychrome, stone, and tile embellishments. Many are in multiple occupancy and numerous front gardens have given way to off-road parking. However, the properties have been well-managed and maintained, affording the streets grand appearances. Multiple occupancy has not detracted from the streetscape in this area as significantly as other parts of the Conservation Area.

Polychrome houses along the north side of Castle Crescent

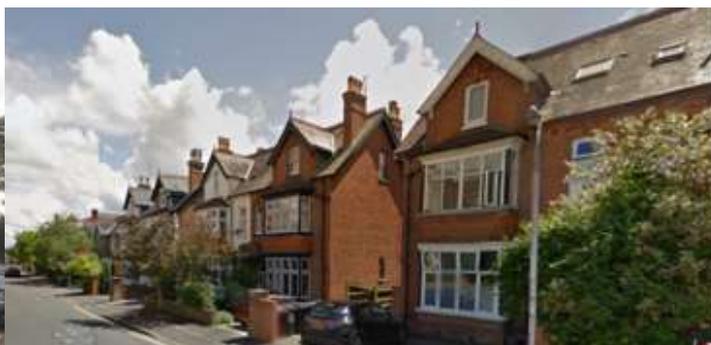
Polychrome, tile and terracotta detailed houses along Mansfield Road

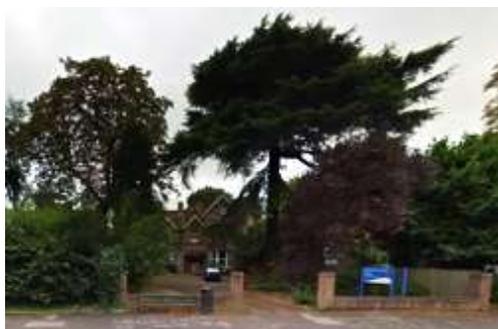
5, 7 and 9 Bath Road, date from c.1880-90 and were incorporated into the Conservation Area in the 2004 Appraisal. Each has a similar appearance to the villas of the same time period on Castle Crescent. The houses are set back from Bath Road, with a similar alignment to that of the streetline during the mid 19th century. These properties have attractive, deep front gardens with striking trees that are safeguarded by TPO's.

Large polychrome villas set back amongst striking trees, Bath Road

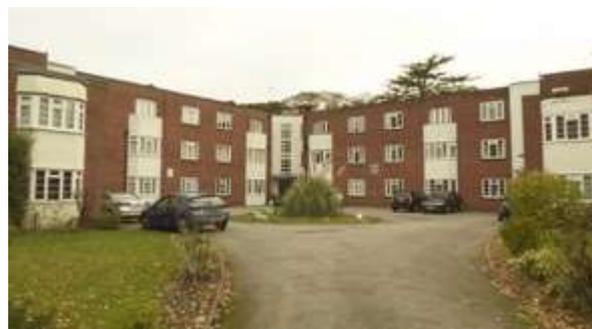
The listed building at the south east corner of the junction of Castle Crescent and Coley Avenue functions as a B&B but is poorly maintained. The mid-20th century Berkeley Court opposite, is set well back in an attractively kept garden. Its rear portion is the former entrance of an earlier manor house on the site. Newer windows detract from its otherwise attractive mid-20th century design, which is unique to the area.

The mid 20th century Berkeley Court, Coley Avenue

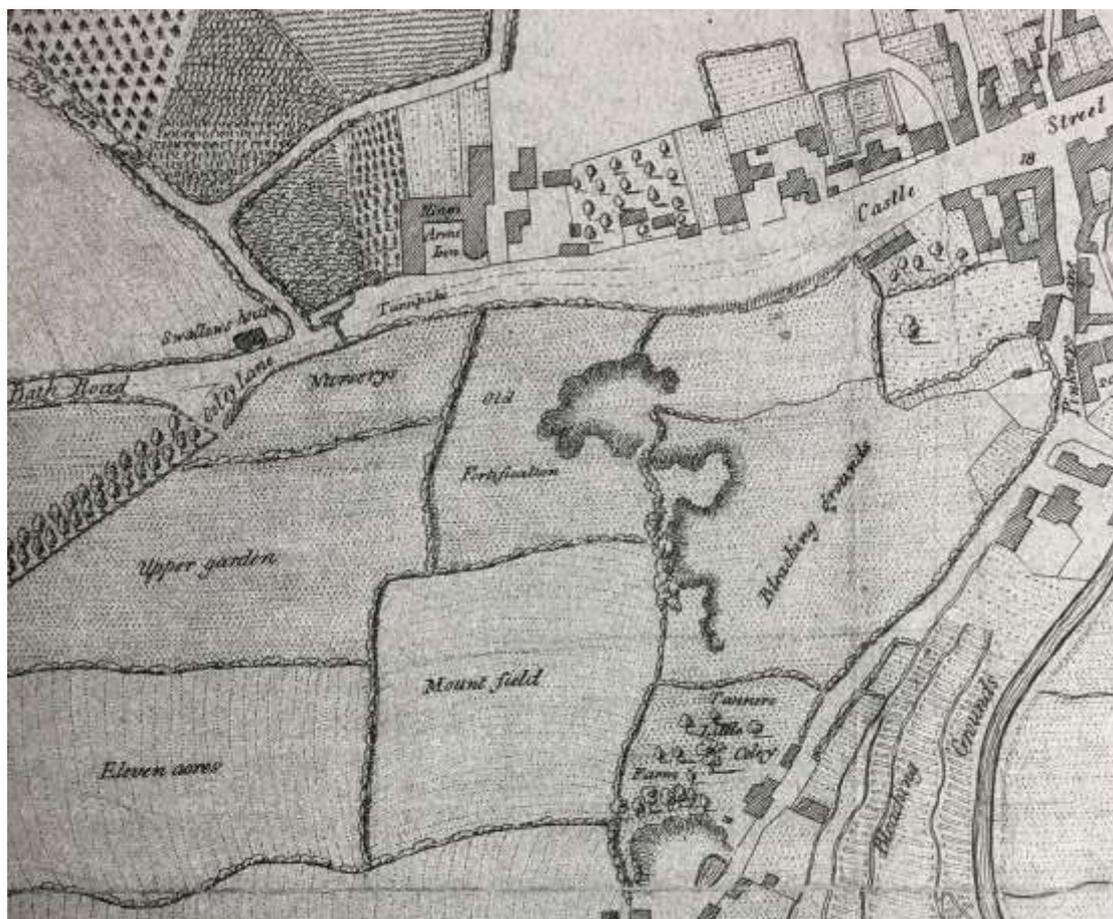
Part of Coates Map 1802 showing 'Old Fortifications'
