Russell Street/Castle Hill Conservation Area

Draft Conservation Area Appraisal

Reading
Borough Council

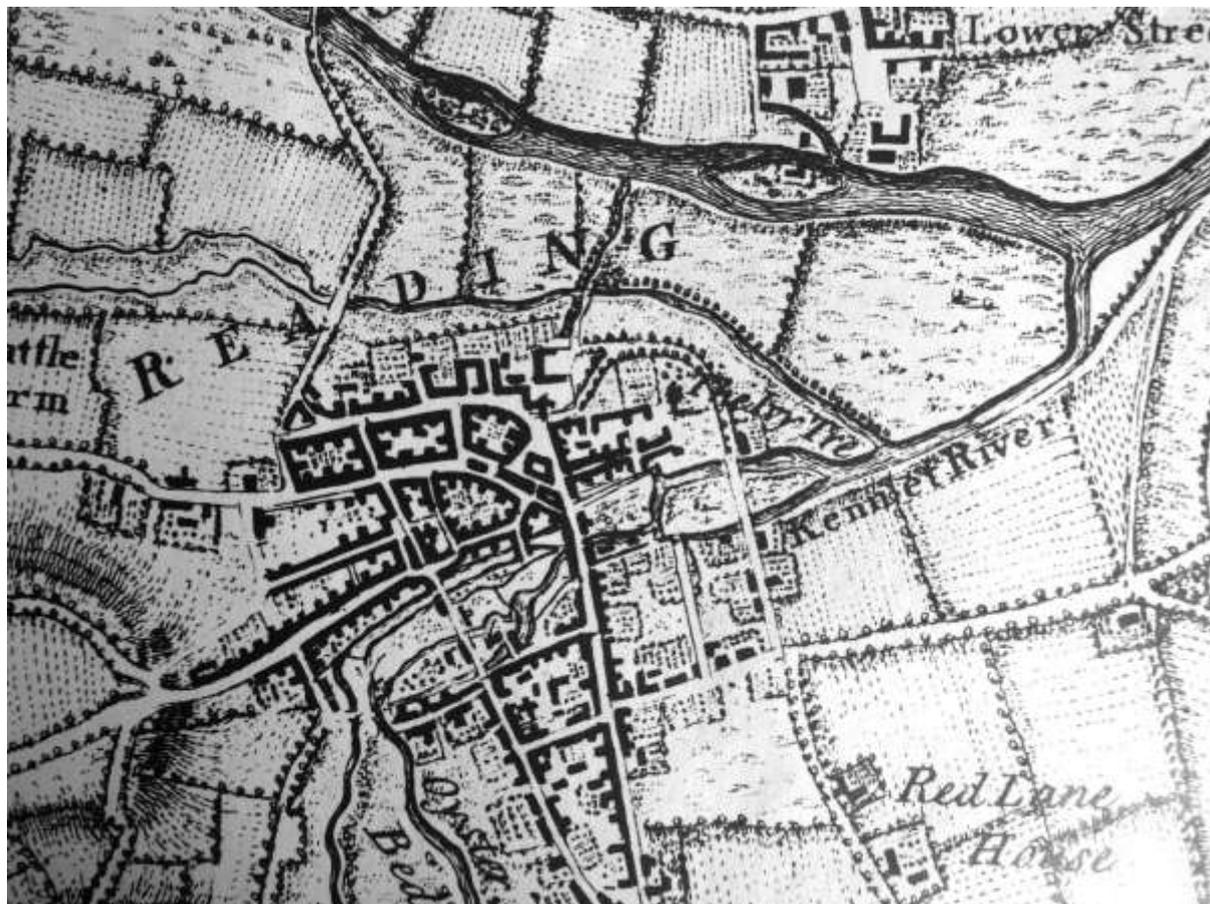
John Rocque's map of 1761 shows plots on the north side of what is now Castle Hill were occupied with southern views across Coley Gorge. Most of those buildings were subsequently demolished or redeveloped.

Extract from Rocque's Map of Reading 1761

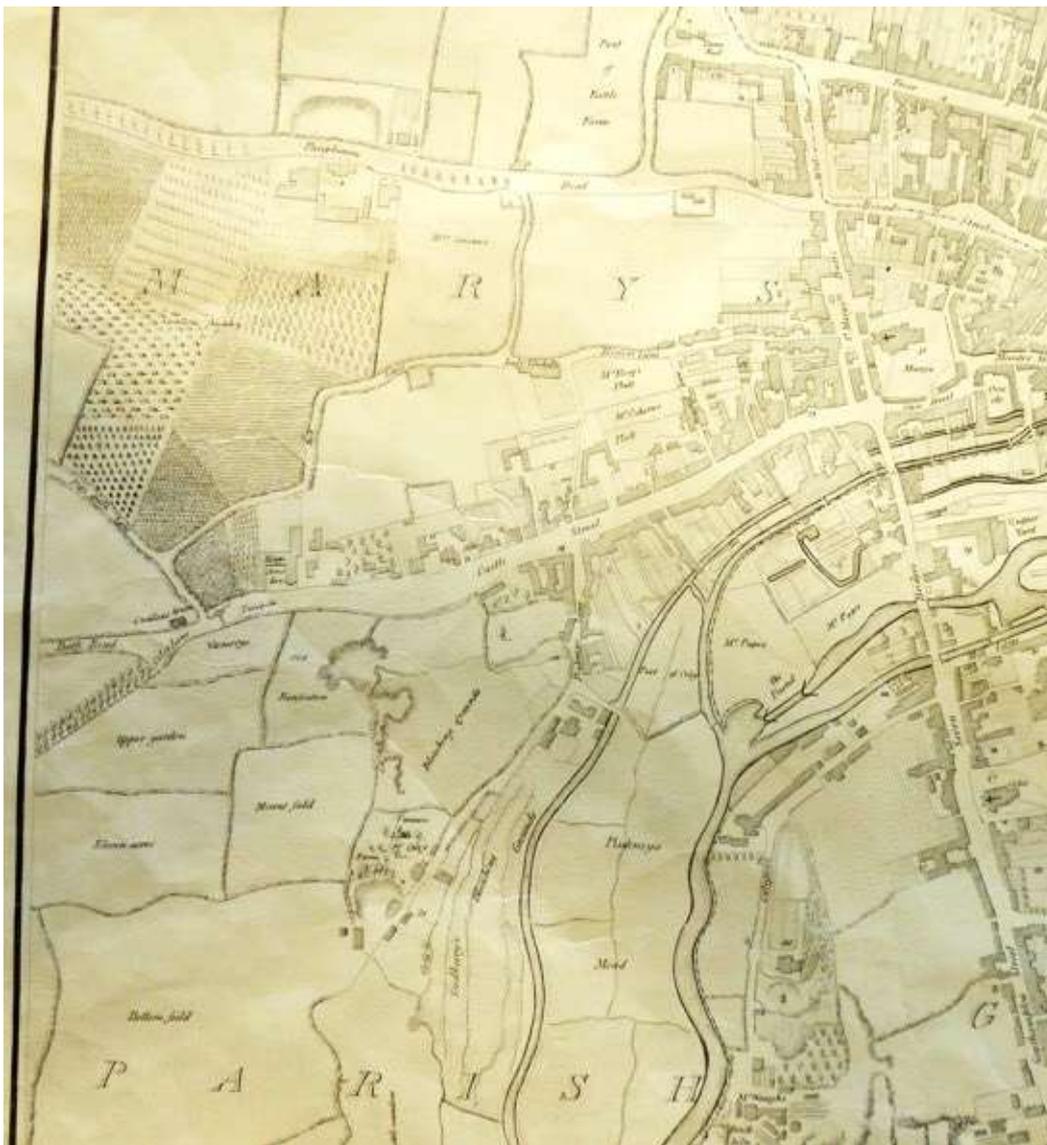
Part of Thomas Coates' map, 1802

Mrs. Zinzan's fields are also noted on Coates' map located in the area between today's Waylen Street and Howard Street. They were part of the sizeable local nursery industry in the area supplying vegetables and fruit to the town. The fields were sold off in the 1830s and Waylen Street and Zinzan Street were laid out after that sale. There was another plant nursery named Victoria Nursery just north of the Oxford Road located between the railway and Mason Street and shown on the First Edition Ordnance Survey map (1877).

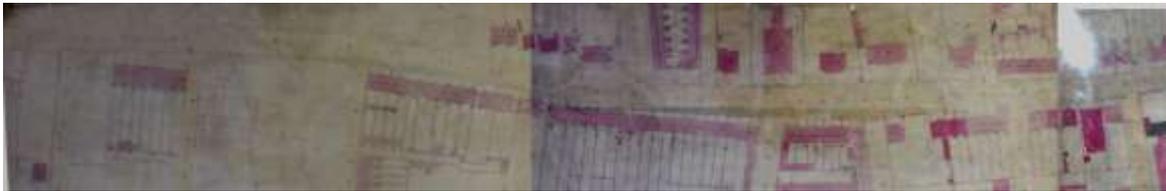
Oxford Road, Sanitation Map 1853 showing development west to Prospect Street with Prospect Terrace still separate to the west (RESHOOT)

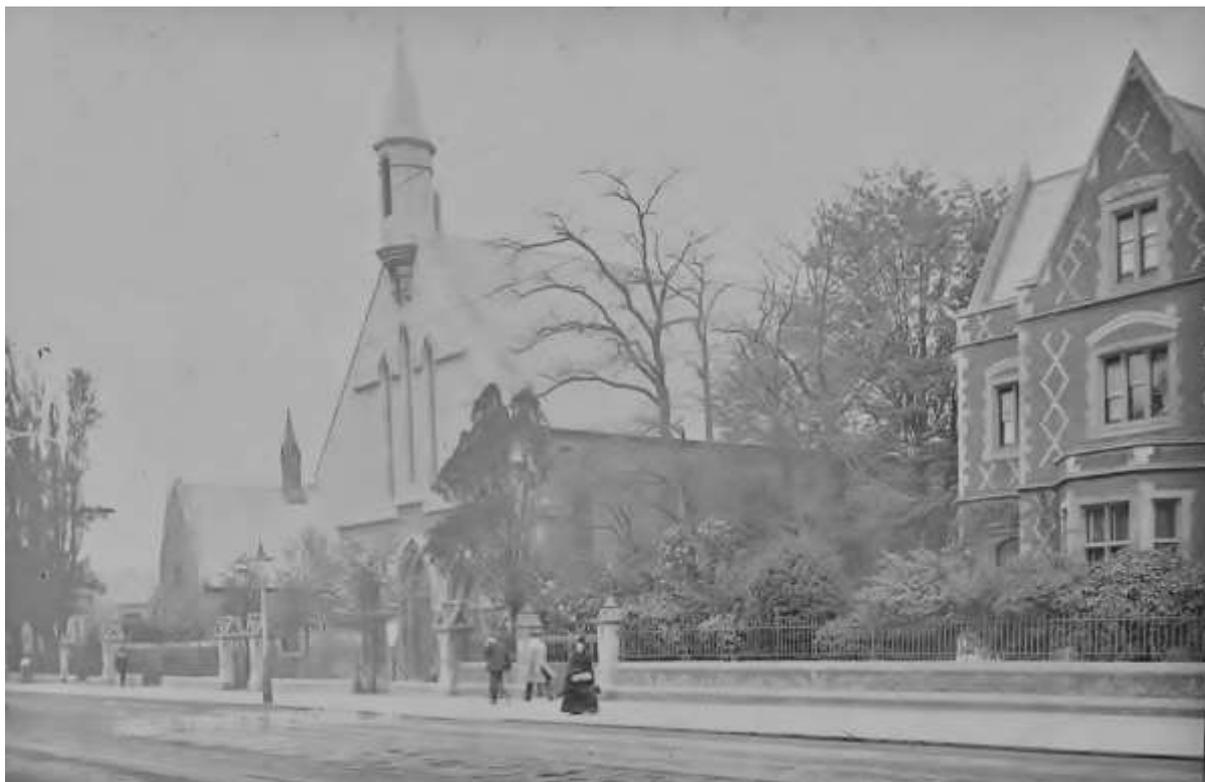
Among the historic churches and places of worship in the area Holy Trinity parish church stands on Oxford Road at the intersection with Russell Street. In 1826 the Reverend George Hulme purchased the site to build a proprietary chapel over the gravel pits in that location in order to construct catacombs. He counted on the high fees which Reading's wealthiest citizens would pay to use the church's burial vaults. Proprietary chapels were not compelled to follow the rules of the traditional orientation of altars facing east. Thus, there is a striking view down Russell Street to its front entrance. The catacombs were sealed off in 1858, due largely to the fact that they kept filling with water but were later used during the Second World War as an air raid shelter.

Holy Trinity Parish Church, Oxford Road, late 19th century. Hulme's Villas sit to its east on the right

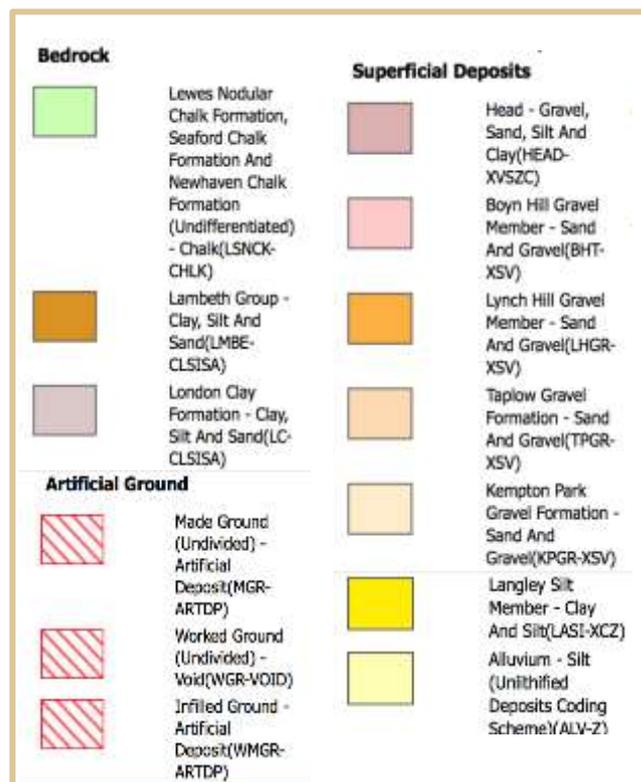
The area sits atop a high mound of clay, silt and sand covering most of the southern portion of the conservation area. Castle Hill sits along the high ridge of that clay. As the land falls away from this ridge towards the north and to the south east, the clay ridge gives way to underlying chalk. The northern most part of the conservation area is made up of sand and gravel deposits which continue northwards to the alluvial deposits of the River Thames beyond. As the higher ground slopes down towards the River Kennet and the Holybrook in the southeastern portion

of the conservation area south of Castle Street, the alluvial silt deposits of the river bed are present.
