Russell Street/ Castle Hill Conservation Area

First draft re-appraisal presented for the approval of
Reading Borough Council
developed by the Reading Conservation Area Advisory Committee (CAAC)
and the Baker Street Area Neighbourhood Association (BSANA)
April 2017

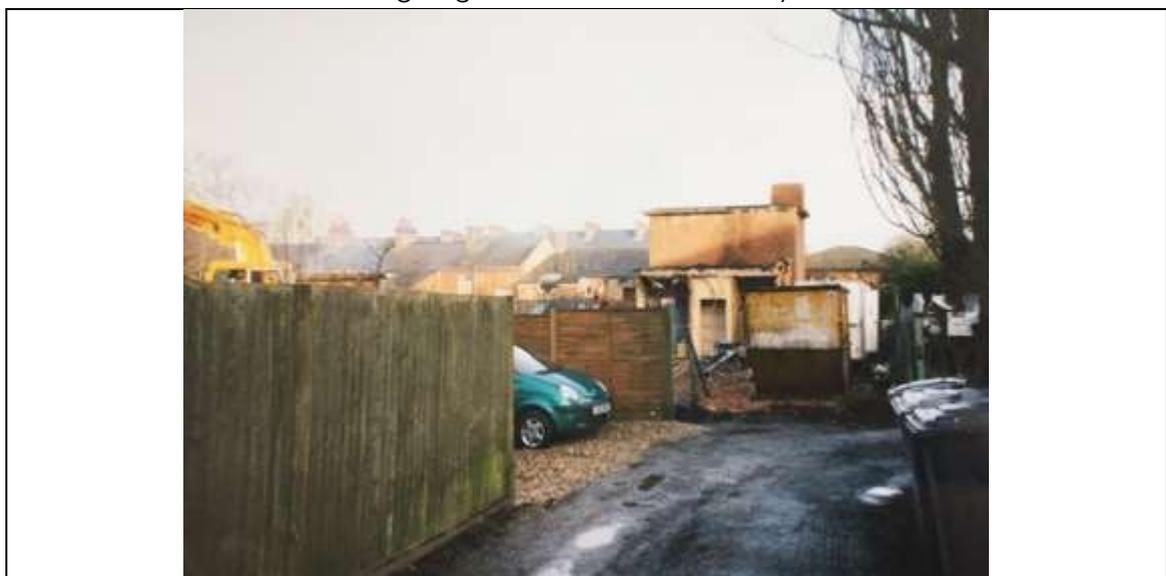
The old slipper baths behind Jesse Terrace ,
in demolition, 2003, photo courtesy of Alan

Many of the local terraced streets in the conservation area did not have bathrooms, as bathrooms did not form part of the original design of many of the more working class households and many of the houses were served by communal baths. As a reminder of this life that continued well into the 20c, slipper baths were located to the rear of Jesse Terrace, back of Castle Street, constructed as late as the 1940s or 1950s. The building was recorded as part of an archaeological investigation. It was noted to be T-shaped in plan, constructed of bricks and concrete and strengthened glass skylights. It had a reception room, boiler room and two storage areas on the ground floor and a second storey pump room. The main longitudinal body of the building contained the wash rooms along a central corridor. The baths, later derelict, and attracting vagrants and ASB, were only torn down c. 2003.

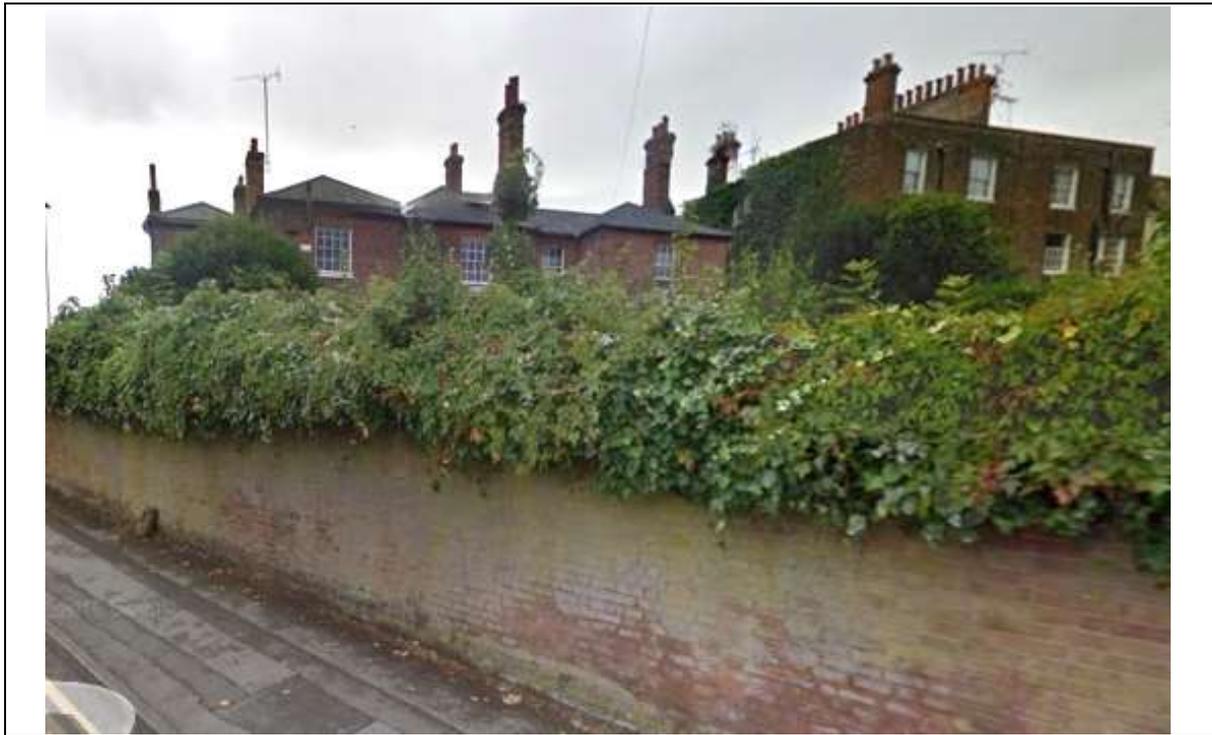
The chimney view at the back of Swallow's residence (2 Bath Road) and 4 Bath Road

The view to the back of Henry Pratt Swallow's residence at 2 Bath Road (no. 13) is a striking one within the conservation area but an equally easily missed view as the traffic there limits the desire or chance to linger comfortably at the view. The many and tall chimney spires of Swallow's residence and 4 Bath Road next door form a grand, charmingly austere view not often seen in such an urban setting.

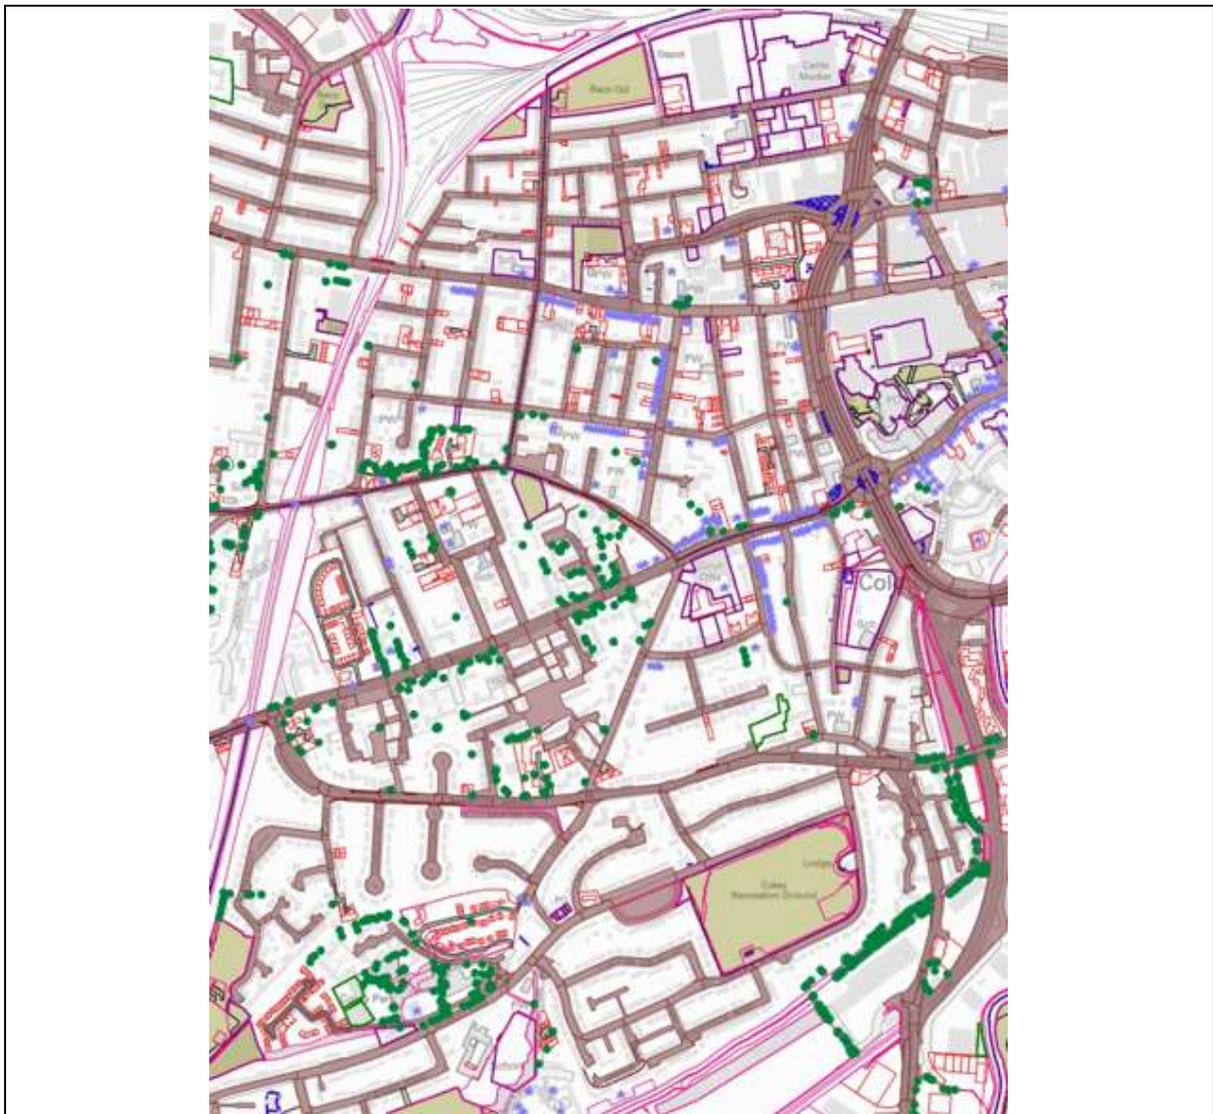
Map from RBC-
(to be replaced with scale- readable map) green dots denote TPOs -missing back of 29 Russell)

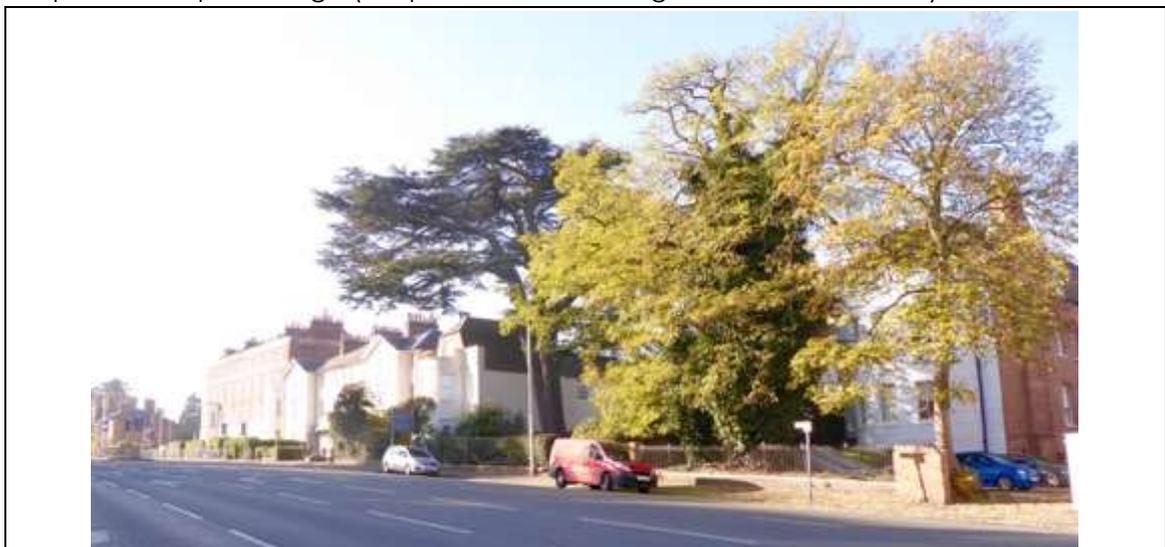
The large cypress at 154- 160 Castle Hill and other TPO trees along the street

- the huge cypress at 154- 160 Castle Hill- possibly up to 200 years of age
- the appx 100-year-old Oak tree at the corner of Goldsmid Road framing the turn of the road
- the small group of trees at the front of the Holy Trinity Parish Church
- several of the large mature cypress trees along the Bath Road
- Several of the mature specimens in the front garden at Yeomanry House which provide a quite refuge (despite the surrounding traffic for that area.)

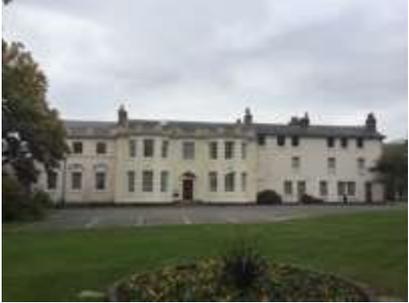
<p>Yeomanry House and its altered façade with filled in Georgian arch windows and its later Victorian extension to the right</p>	<p>3 Castle Crescent – dilapidated late Georgian manor house with quoins and porticoed front entrance porch.</p>

Yeomanry House provides an idea of the styling of the large houses with surrounding gardens that catered to Reading's wealthiest citizens at the onset of the 19c. Yeomanry house is a two story, stuccoed front manor house with a central door and windows that were placed in classic Georgian style. Sadly, the building is much altered, with arched windows on the ground floor which have been filled into accommodate a smaller fenestration. On the right hand side, a later Victorian addition destroys the symmetry of the front of the property as it would have originally appeared. However, the columned balustrade and the double curved front bays can give the observer an idea of the former grandeur of the property in its original layout.

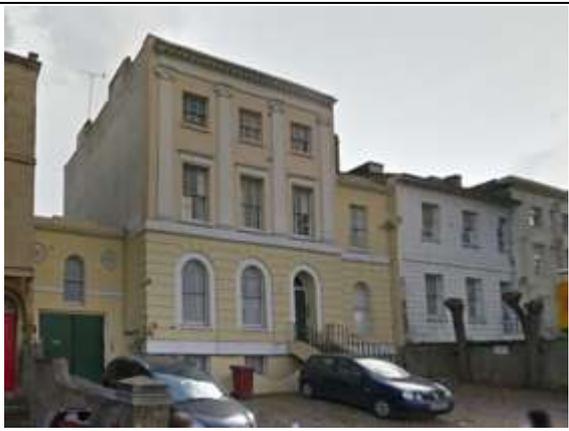
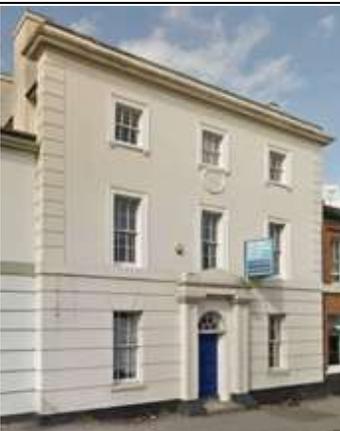
<p>107-109 Castle Street with long staircases going to the ground floor, rosette detailing above</p>	<p>122 Castle Street with rusticated ground floor, side mock- quoin pilasters , regency detailed</p>

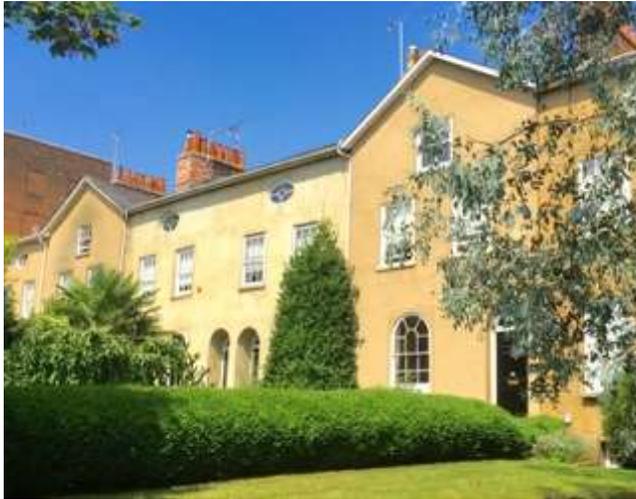
The unusual Bath-stone coloured stucco fronts of 134- 144 Castle Hill with its long front gardens and its regency style oval windows

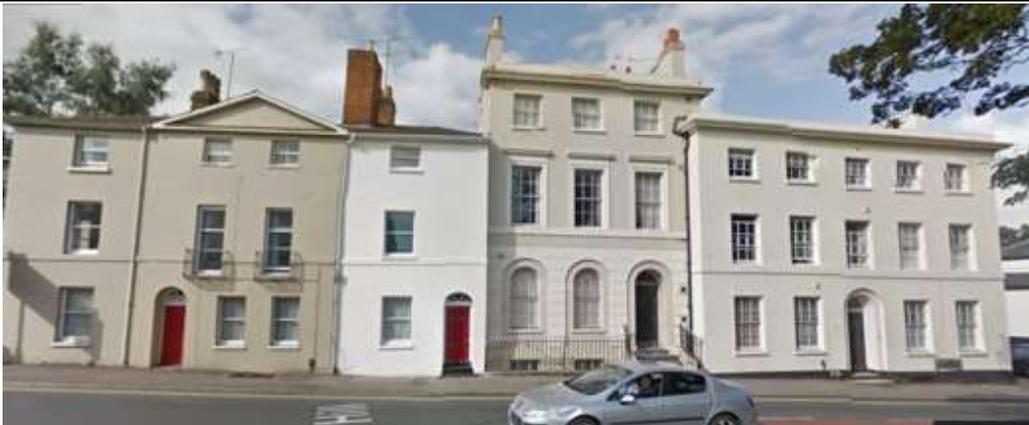
Plethora of details at 132- 124 Castle Street: a triangular pediment above a formerly joined dwelling, rusticated ground floors, detailed fanlights, basement/undercrofts, cornice mouldings and traditional window placements

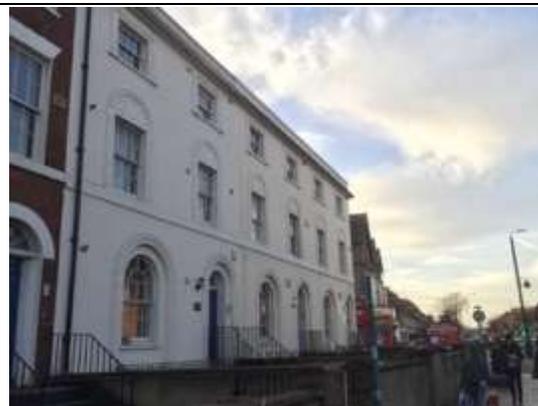
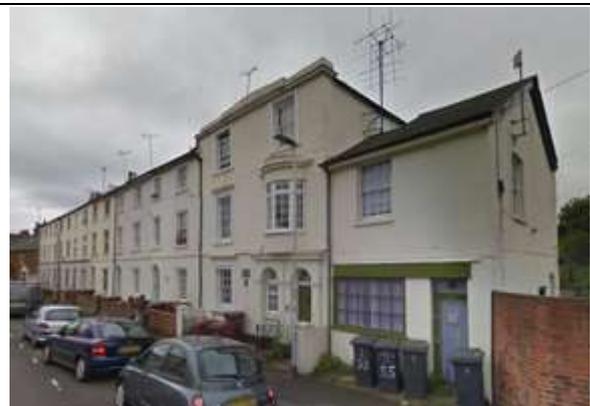
Red brick frontage Georgian terraces are more common along the west side of Russell Street, the terrace to the west of Russell Street on Baker Street, the terrace along the Oxford Road between Lorne Street and Argyle Street and long terrace along Coley Hill. Whilst there

are some three-story properties with basements, two story properties are common. Fanlights over the doors, arched windows, contrasting wide banded first floor courses are common on these properties.

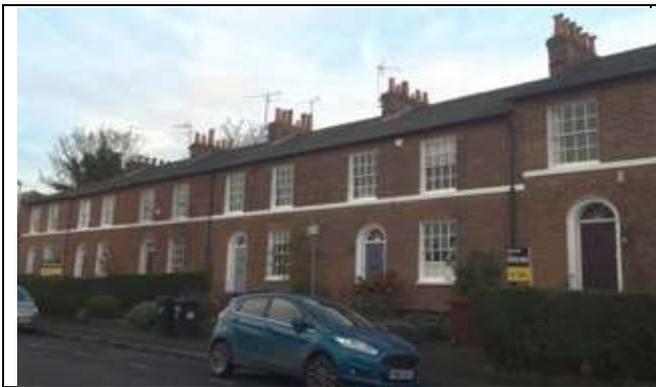
Baker Street terrace c 1820s

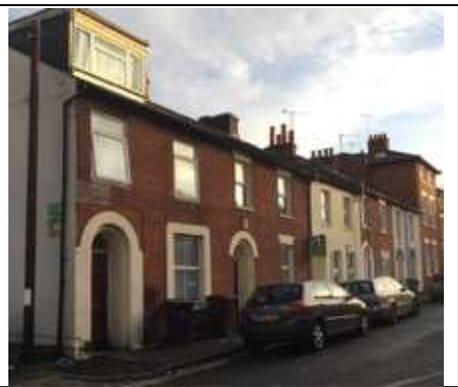
1-9 Prospect Street, humble working man Georgians

Of particular note to the Conservation Area , are a small collection of more humble Georgian style housing at nos 1-9 Prospect Street. This collection is a charming group of a humble two story Georgian properties for the more common working man in the first decades of the 19th century. They sit in sharp contrast to the grander Georgians in the area which were built for Reading's wealthiest businessmen. Sadly, the Prospect Street properties have been greatly maligned over the years and only no 9 contains the original sash windows and fanlight of the property.

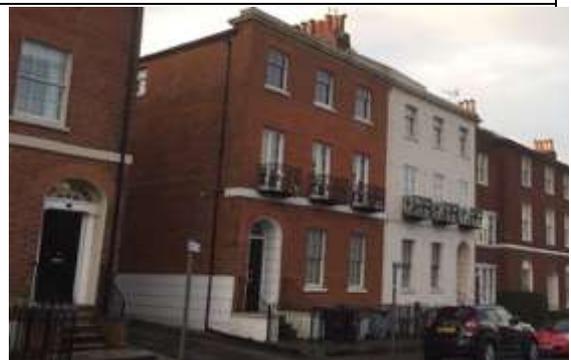
Georgians on Russell Street with wrought iron window balconies

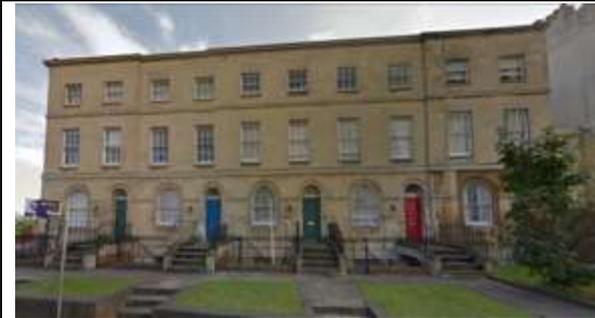
Blenheim Terrace, Castle Street

Bath stone made a limited appearance in the conservation area at 48–50 Russell Street and at the striking Blenheim Terrace at 97-105 Castle Street. Far greater examples of the use of Bath stone exist to the east of the centre of town, notably in the Eldon Square Conservation Area. The semi-detached villa at 48-50 Russell Street is the only one of its kind in this conservation area but in the Eldon Square Conservation Area, there are many near duplicates of this property. Bath stone was believed to have been imported along the Kennet Canal into town and was a material used in Reading for its prestige value.

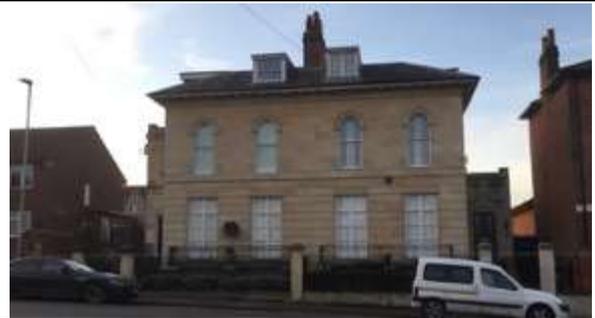
48-50 Russell Street

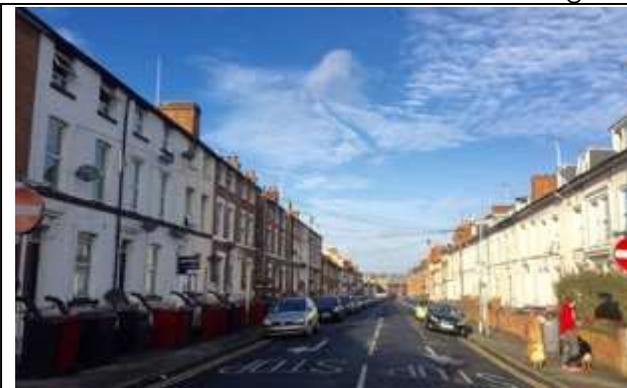
Waylen Street terraced housing c 1840

The late 1830s-1850s saw the building of the more scaled back and humble Victorian terraced housing as along Waylen Street, Zinzan Street and Howard Street. Most of these houses are three-storey with the basement properties, but the scale of the homes and their interior rooms are more diminutive in size than their earlier Georgian counterparts. Sadly, these are some of the most maligned properties in the conservation area, but originally all would have boasted of sash windows and panel door fronts under simple squared-off fanlight/transom windows above. Chimneys and chimney pots largely remain but have also seen removal in recent years. Virtually no original windows remain on any of the streets and more modern build square, simple dormers have been added to rooflines to increase the living space inside most of these properties that are detrimental to the properties' appearances. The vast majority of the properties were originally red brick fronts. Today many of them are painted over and the striking appearance of red bricked terraces has been sadly lost. Frontages onto the pavement of these properties which are original are rarely found in the area today with no. 16-26 Howard Street providing the best original fronts, which consisted low stone or brick walls with wrought iron railings.

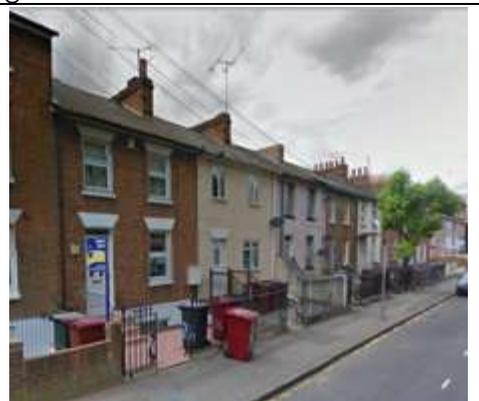
Howard Street terraced housing with original railings on pavement frontages

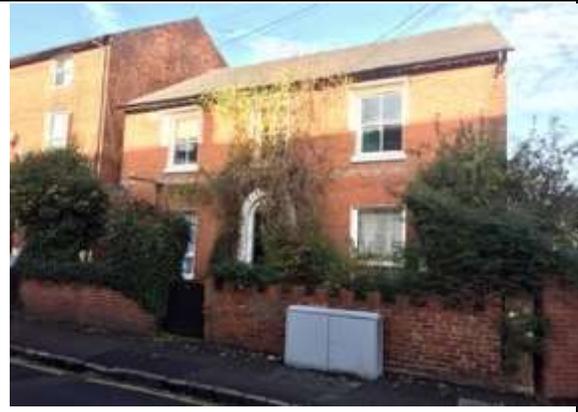
14 Baker Street, a rare detached "cottage" style Victorian residence

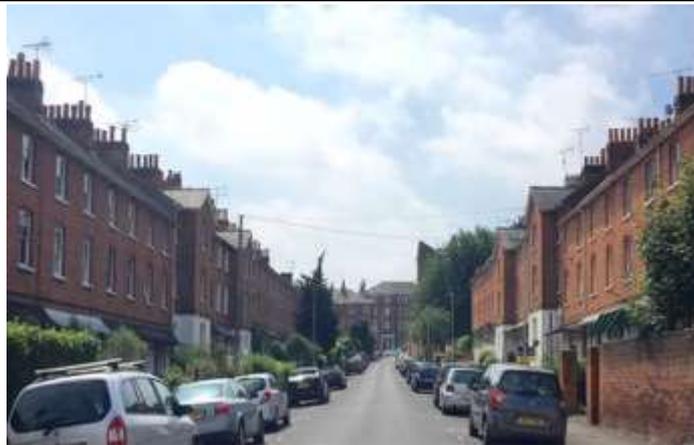
Jesse Terrace, looking south towards Castle Hill

The very attractive houses of Jesse Terrace were the vision of the local Jesse family, and were started c. 1850, built in groups of four or so at a time. These were a grander sized house than the slightly earlier homes to the streets north and the charming veranda front porches with their concave metal roofs provide the range with a unifying detail that sets the street apart. The houses front gardens, with their Victorian tile front pathways are well taken care of and within Reading, they remain a rather unique example of a unified Victorian street built for the wealthier businessman.

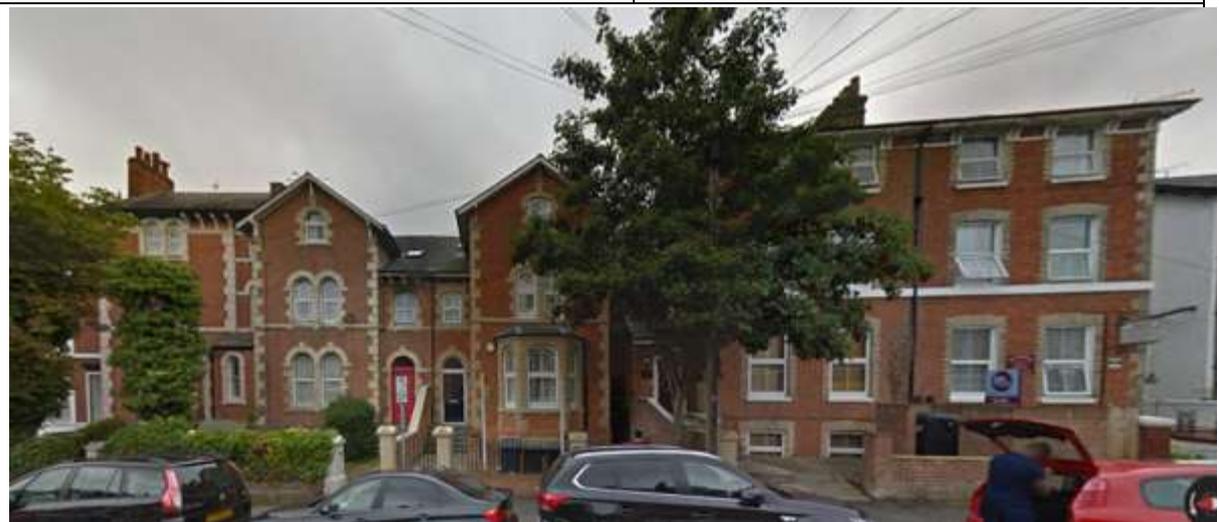
Polychrome detailing on large properties, east side of Russell Street

From the 1870s to the turn of the 20th century, the remainder of the area was filled with housing. This time period saw two primary types of houses being built. The grand red brick and polychrome detached and semi-detached villas of Castle Crescent and Mansfield Road and along the east side of Russell Street north of Baker Street are notable for their detailing and their large massing. Whilst red brick remained a dominant colour, other colours of brick such as grey, tan and white were employed as contrast detailing and occasionally used for the entirety of the property's façade. On some of the properties, terracotta details were introduced around windows and doors to embellish the house front. Many of these houses are three-storey properties with expansive footprints. Some have side door entrances.

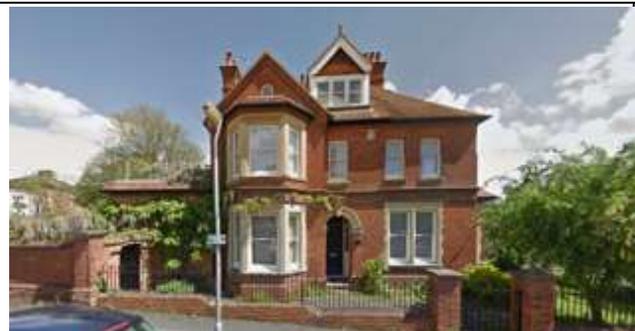
22 Mansfield Road, with stone detailing and Victorian roof tile work

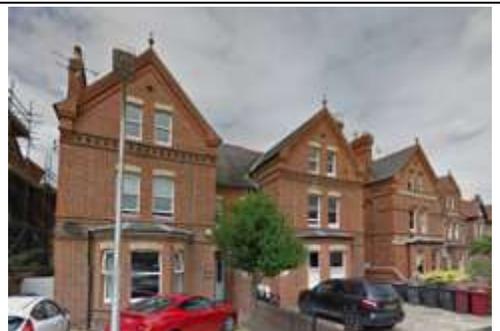
Detailing along houses of Castle Crescent, roofline terracotta trim

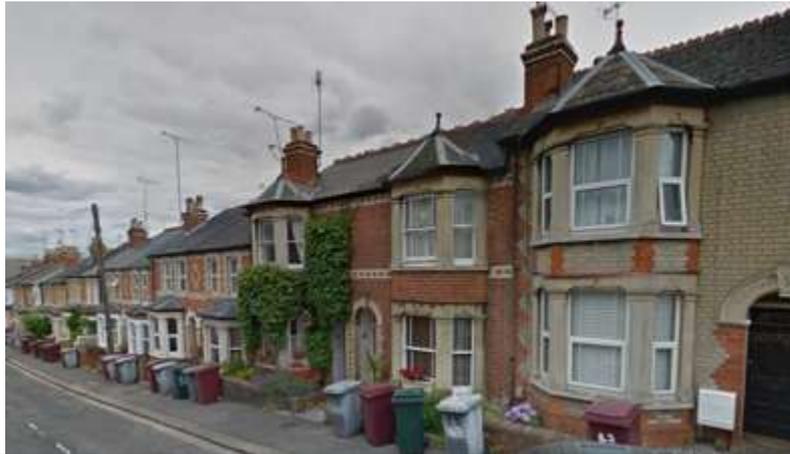
Clifton Street polychrome with pointed bay window roof lines with terracotta points

Concurrently, more humble polychromed and terraced two- up, two- down houses went in along Clifton Street and Franklin Street, Belle Vue Terrace and along the east side of Field Road. Further along the Oxford Road near the railway bridge where the retail area had fallen off has a high preponderance of this type of polychrome styling, on both house fronts and on retail properties. Many of these terraces used the effects of several colours of brick to create eye-catching patterns running along the first floor level that would follow the entire route of the terrace. Sadly, over-painting of some of these houses destroys the beauty of this unifying look. Frequent use of bay frontages are common in the terraces.

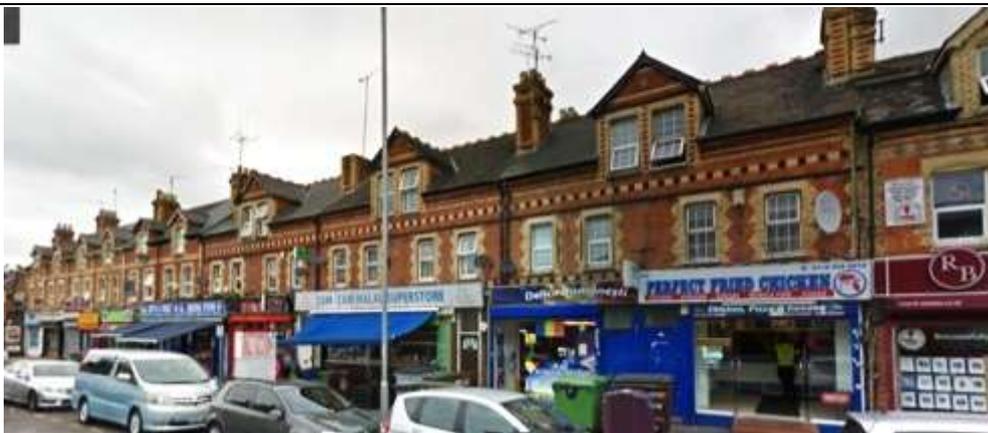
Polychrome first floors of north side shops, Oxford Road

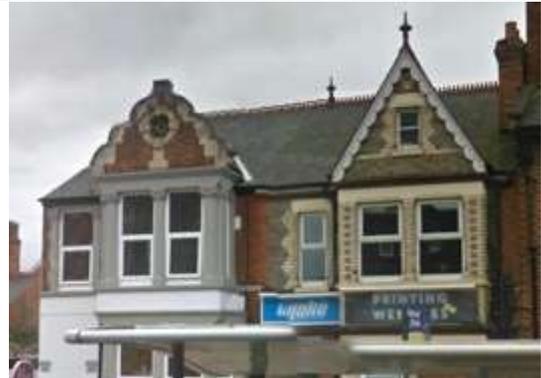
Exuberant rooflines above badly maligned ground floors, Oxford Road

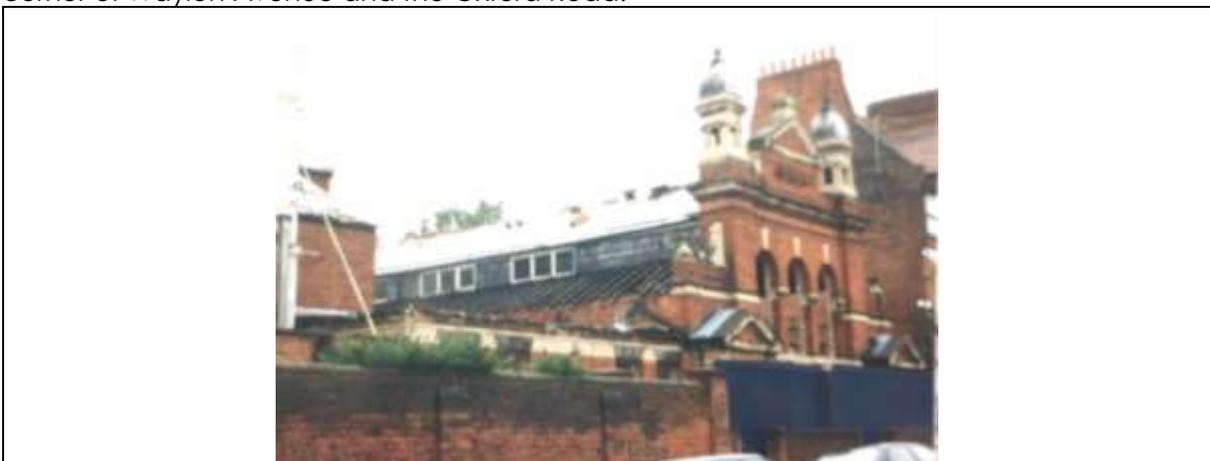
The former Methodist Church, Waylen Street, being dismantled

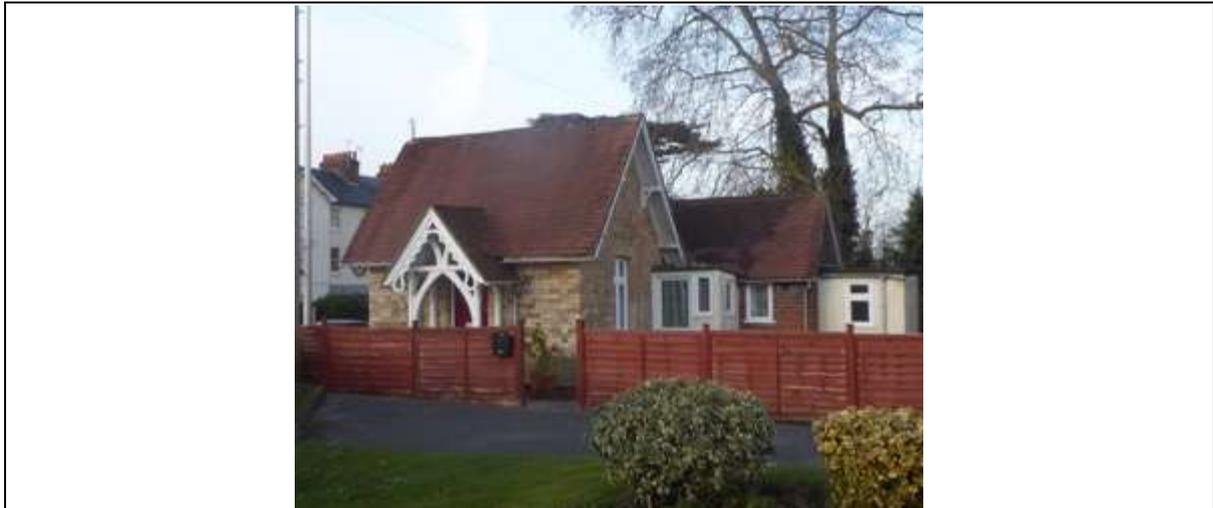
The former Yeomanry House gatehouse, c. 1840s, with unusual salmon coloured stone covering the main front and side elevations with well detailed wooden Victorian embellishment on its street facing eaves (before its 2016 renovation)

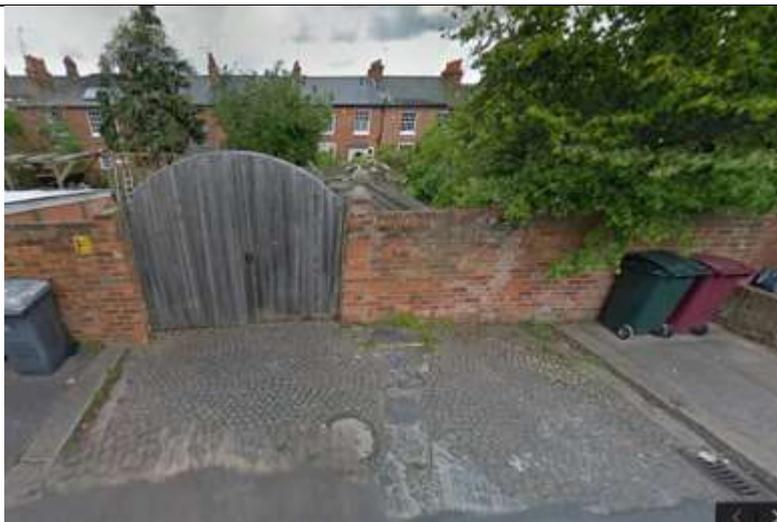
The only bit of paved roadway left in the conservation area at the end of Belle Vue Road, in typical sett stone fan pattern

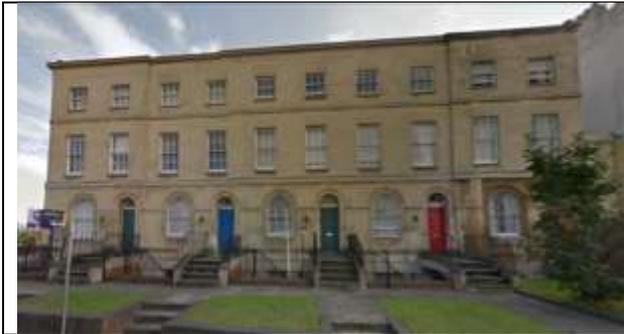
Blenheim Terrace, Bath stone terrace, 97-105 Castle Street

The early 19c Bath stone Blenheim Terrace, from 97- 105 is attractive and generally well-maintained, with the exception of 105 in a poor state of repair, and represents one of only two major uses of Bath stone in the conservation area.

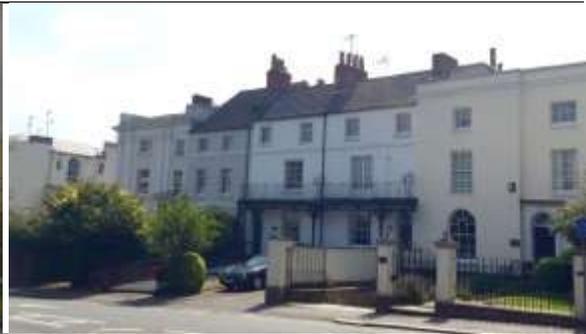
Charmingly diverse terrace of Georgian properties 113-121 Castle Street

The fine stand of houses from 113-121 form a typical terrace of large grand Georgian homes of differing appearances. The terrace is an extremely attractive stand of houses because of this variety, despite regrettable dropped kerbs to the fronts. The rusticated paired and channeled pilasterstrips topped with wreaths of 113 form a particularly striking end of terrace property. The house lost its stable entrance c.1900 when the entrance to Field Road was created.

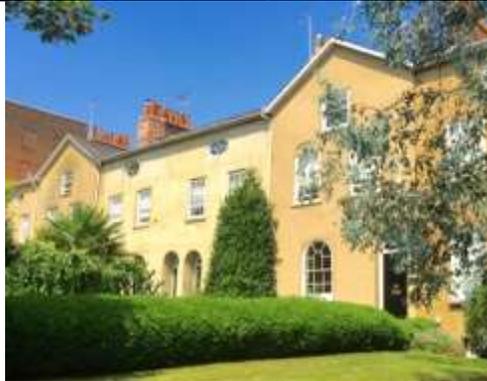
Bath stone coloured stuccoed Regency style terrace, 134- 144 Castle Hill

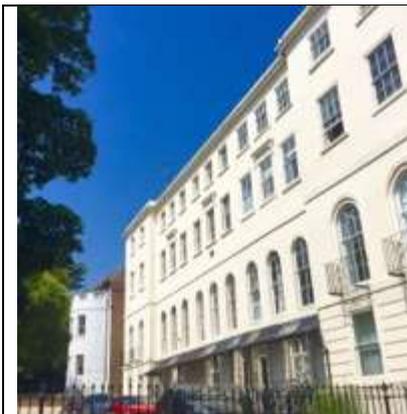
Thomas Jesse and his family of developers ensconced at 154-160 Castle Hill had great interest in the surrounding area, and their hand in developing has a particular mark to it, displayed to its best in a number of the properties along the route, notably at Heritage Court (144A – 152) and further down the road at 162A- 166 which have attractive verandas with concave metal roofing (reminiscent of the nearby Jesse Terrace) and Regency style metal work.

Heritage Court, Jesse family developed, 144A- 152 Castle Hill

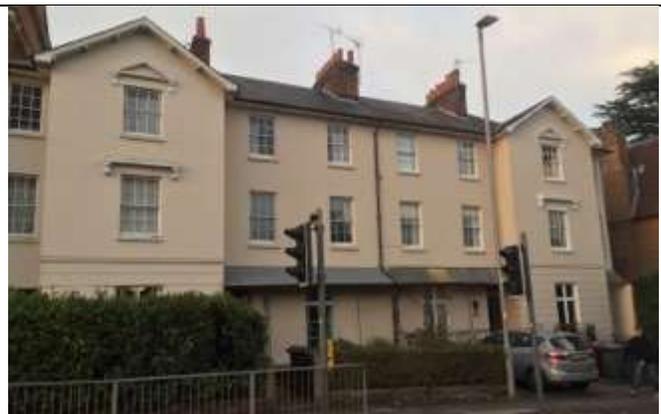
Terrace with Regency iron detailing, Jesse family developed, 162-168 Castle Hill

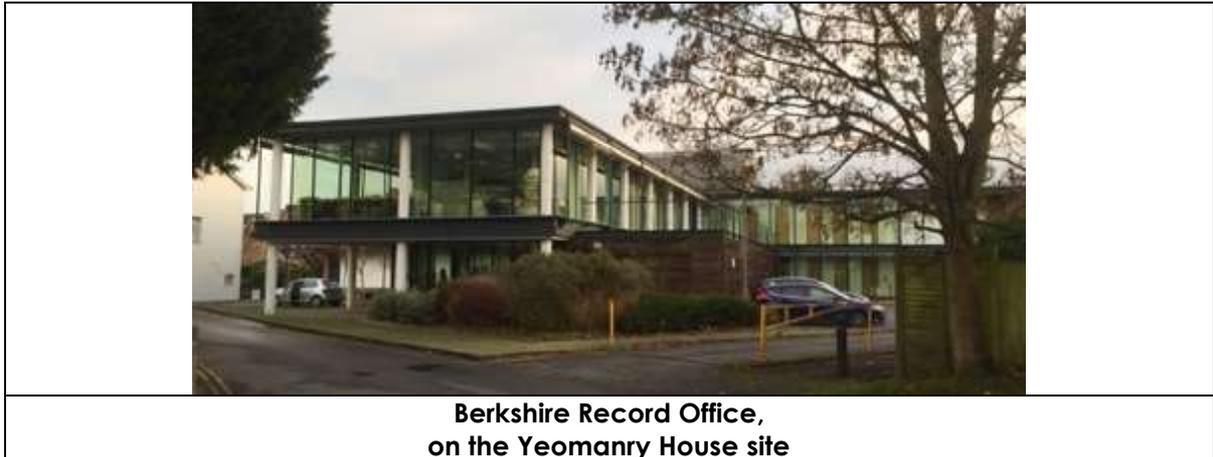
The modern purpose built Berkshire Record Office on the Yeomanry House site, is substantial in size, but commendable for the design of its façade and its footprint which sets it back in a subservient fashion from the historic house and its front gardens. The late 20c residential building at 129 Castle Hill is the most substantial drawback to the street. The flats at Castlegate at 114 Castle Street, though recent, attempted reasonably well to draw upon cues from the Georgian street and as a result, is a far less innocuous intrusion on the street.

**Berkshire Record Office,
on the Yeomanry House site**

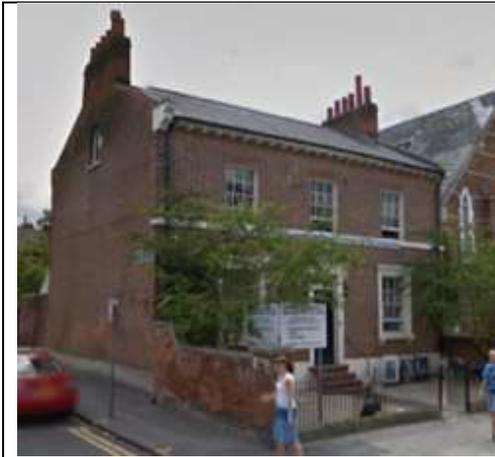
Reading Welfare Rights- detached Georgian with original high back garden walls

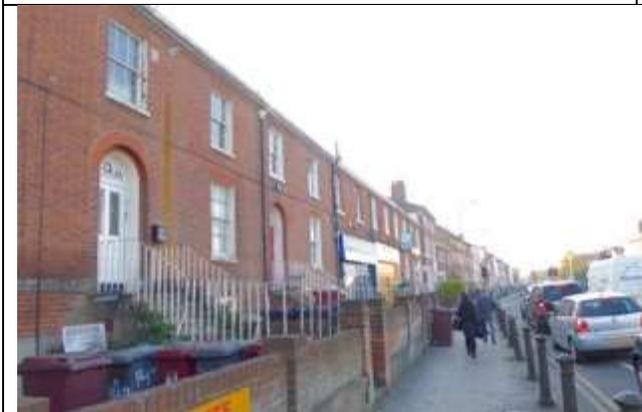
Run-down Georgian Terrace 147 on west

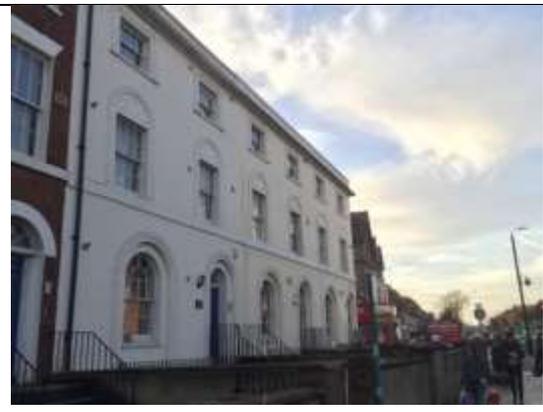
Grand stuccoed Georgian Sidney Terrace at 197-203 Oxford Road

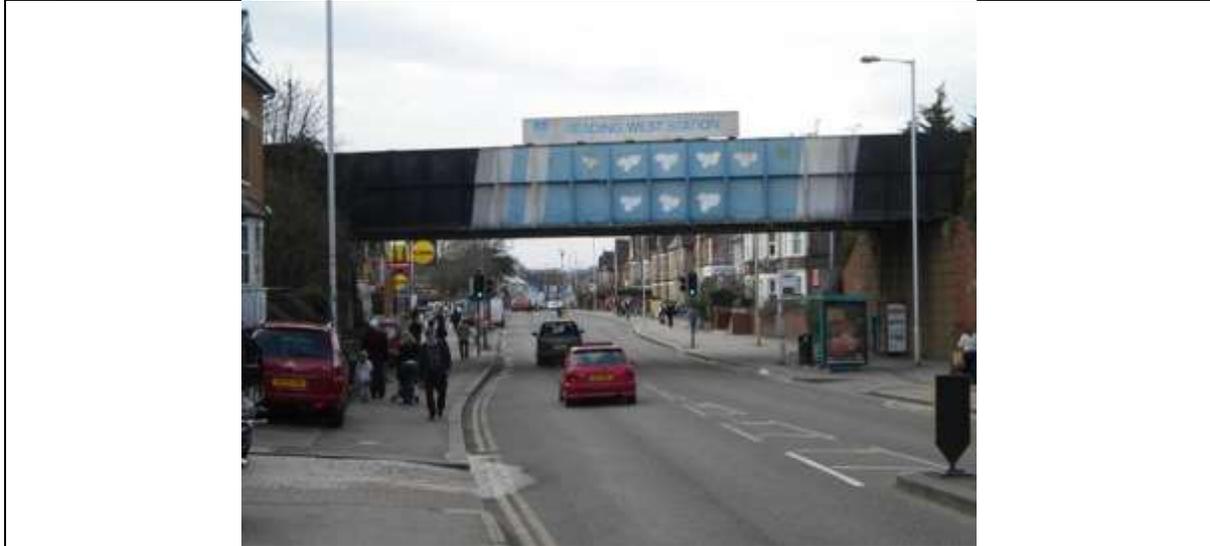
its past-expiration decoration, designed by school children in the 1980s, the railway bridge still speaks volumes about the exciting past along the Oxford Road in the 19c.

**Reading West railway bridge,
Oxford Road**

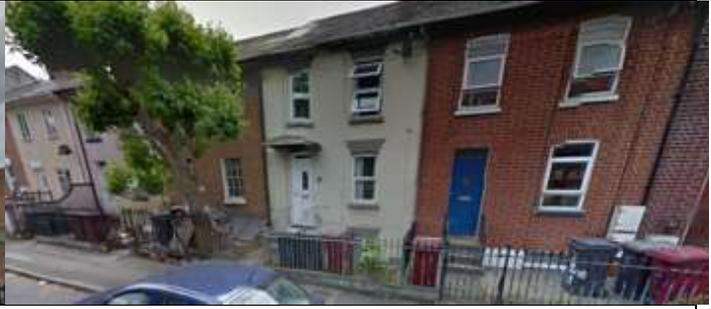
Original iron railings and stuccoed separator wall from 16-22 Howard Street (google maps)

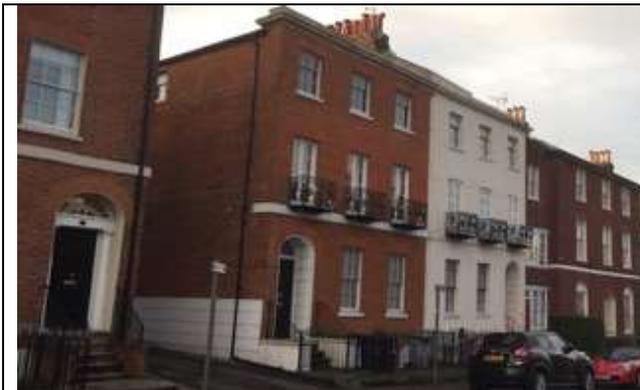
Terraces along the west side of Russell Street (38-42) with Regency window balconies

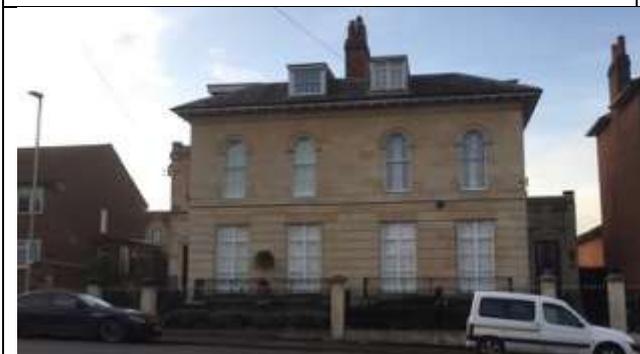
48-50 Russell Street, bath stone semi-detached, as those in Eldon Square

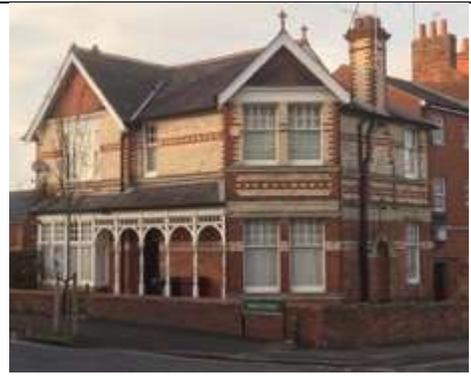
The parsonage (c 1890) at the northeast corner of Baker Street and Russell Street with attractive polychrome and wooden detailing

The parsonage – originally of the Holy Trinity parish church, is a late c1890s Victorian with notable polychrome and terracotta features, still retaining the bars in the upper back window to prevent children from falling out the window from the upstairs nursery. It's Victorian wooden porch is also appositive notable detail. The much larger later Victorian villas on the east side of the street are in varying states of repair, but many have attractive polychrome detailing and a number of original features remain although a few have been sadly over- painted. The Nag's Head public house is a well-restored faux Tudor and enjoys a healthy popularity. It is listed as an Asset of Community Value.

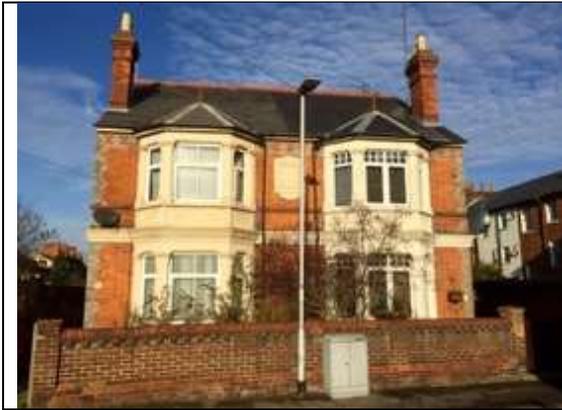
Other buildings of note along Baker Street are Rednirt villas, a semi-detached villa dated 1904 with notable stone work on the outside. Rednirt was the original owner's name spelled backwards: Trinder.

Rednirt Villas 1904, developed by Mr. Trinder, nice bay windows, polychrome and nice stone work detailing

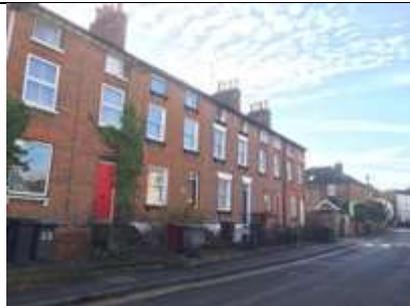
23- 31 Baker Street, iconic Alexandra Terrace, c.1850-1870, simple, honest red brick terrace, fairly-well preserved with largely all original windows and doors intact

The charming, fairly well preserved Alexandra Terrace at 23-31 is notable for its simple, honest, straight-forward red-brick with only the property at 23 being in notable poor condition.

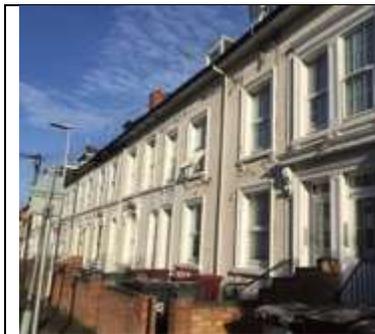
Frontages along Waylen Street's earliest houses c 1840

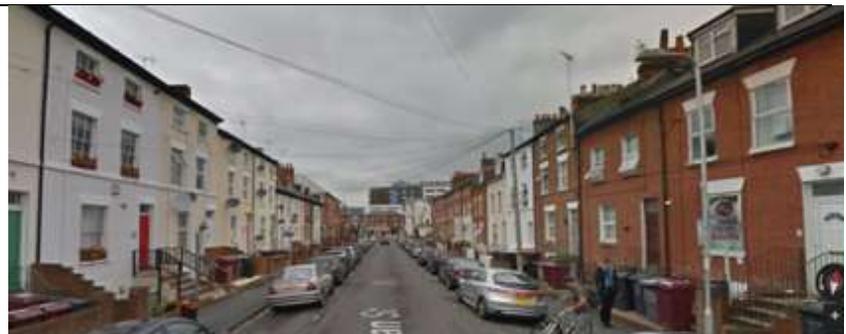
The large terraces along Zinzan Street with its poor condition evidenced. 26 Zinzan Street to the left is the only house with its original windows intact, still in use as a single family house

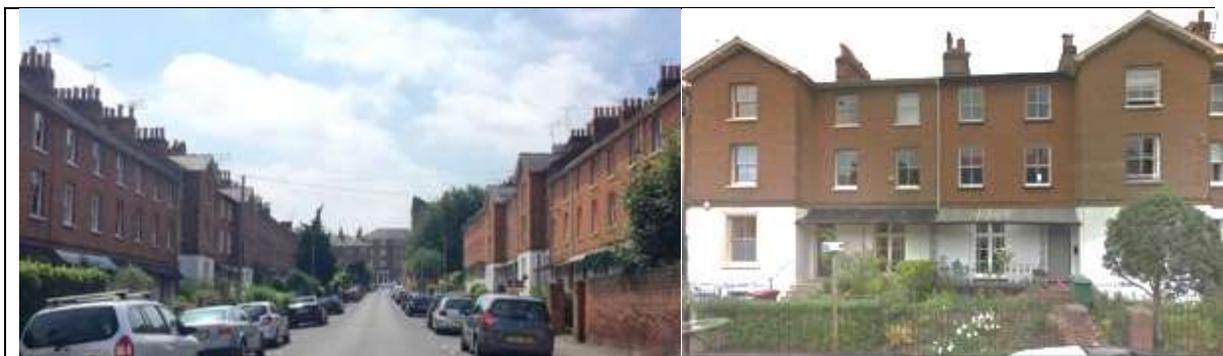
the view up Jesse Terrace from Baker Street to Castle Hill

A close-up of the centre of the east terrace, Jesse Terrace

The remaining housing in the area was largely completed in the latter half of the 19c. The homes on Jesse Terrace were created by the near-by Jesse family in groups of approximately four or a time, with only the earliest group (nos. 1-13) being in place prior to 1853. The Terrace was largely completed by the mid 1870s and there are subtle differences in the builds of each of the "groups" that are notable to this day. The largely single family homes with well-tended front gardens in front of the charming concave metal veranda fronts, contribute a well-loved charm factor to the street and the street sadly sits as a very attractive island with much degradation around it to its south.

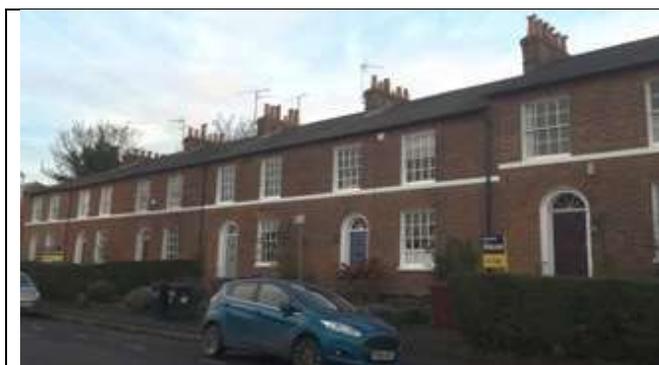
The stand of listed Georgian terraced houses from 61-79 Baker Street, complete with original doors and windows

The stand of listed Georgian terraced housing on the south side of Baker Street (nos. 61-79) c.1820s, was part of this development. The terrace is extremely well cared for with original windows and doors on the properties and is a credit to the area. The relatively new iron railings at number 69 are exact copies of the railings that existed all along the terrace when it was built.

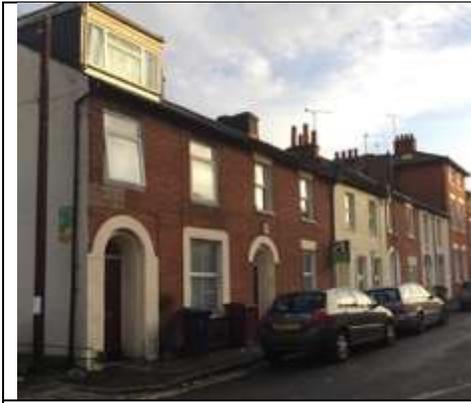
1-9 Prospect Street, humble Georgians in poor repair

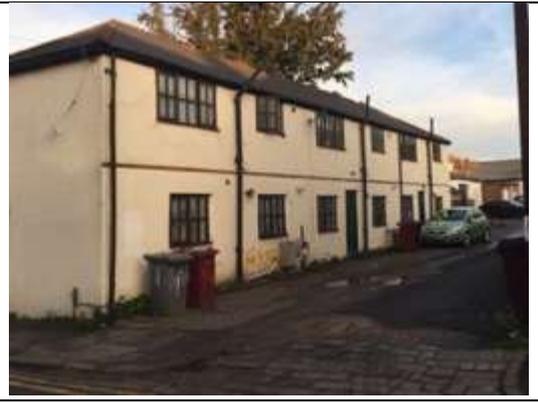
Prospect Mews, mews houses

Additionally, there was development along the east side of Prospect Street from the Oxford Road up to Baker Street. The charming two-up two-down late Georgian cottage style terraces nos. 1-9, show how the more working class person lived in the first half of the 19c along with the greatly compromised Prospect Mews that sits behind the grand terraces of the Oxford Road. Like the small Mews properties in Prospect Mews, two of the houses at 5 and 9 are also stuccoed. The house at 9 Prospect Street, still has the original fanlight and windows, along with many original interior features and is in use as a single family residence. The much larger houses from 11- 23, along the east side of Prospect Street between Baker and the Oxford Road, were also built prior to 1853 with the highlighted. Sadly, despite its very early history Prospect Street at this section is subject to low levels of crime and the majority of the houses are used as HMOs and poorly cared for. The street into the Mews still has a good expanse of stone pavement, although the business at the back and the general condition of the area is poor. An alley behind 1-9 Prospect Street is entirely overgrown.

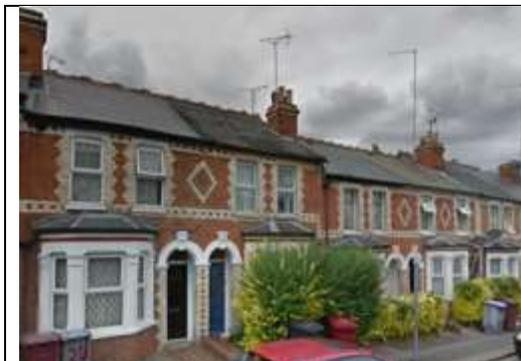
Terraced housing on Franklin Street with the diamond shape polychrome designs between the houses

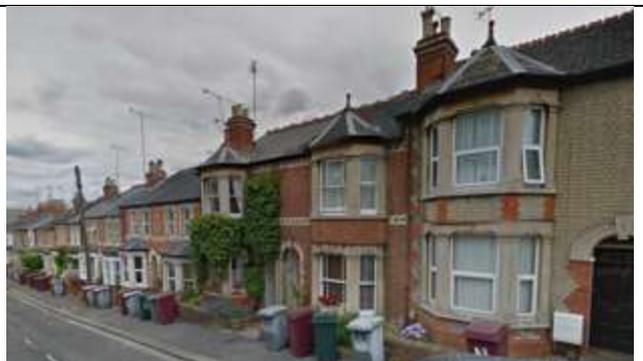
Terraced polychrome houses along Clifton Street, the set to the south with double bay fronts

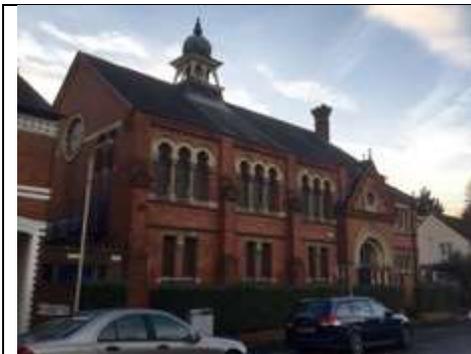
Listed Moorish style synagogue with brick and stone detailing and imaginative bell tower

The listed Reading Synagogue, at the bottom of Clifton at Goldsmid Road built c. 1900, shines as a unique Moorish design in fine polychrome brickwork and stone and is the only purpose –built synagogue in Berkshire. The small wooden bell-tower topped with lead sits proudly on the roof of the synagogue and is charmingly unique. At the bend in Goldsmid Road is a large oak (TPO) that forms an attractive corner for the street.

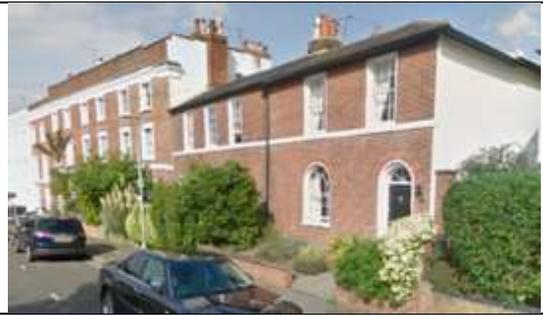
**Arch windows and fanlights on two storey
Georgians, Coley Hill**

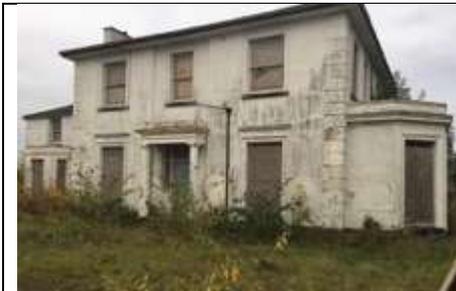
The derelict 3 Castle Crescent c 1840

Castle Crescent was built with several houses dotted the south side of that street c.1840, notably the now derelict 3 Castle Crescent (likely c. 1835- 1840) with its sizeable gardens still in existence today. It currently remains as one of the only four substantial detached villas in the Conservation Area with their grounds intact surrounding them. Its active planning permission to refurbish the manor house and to add more housing along its side to the eastern perimeter along Garnet Hill will challenge the understanding of the garden layout somewhat. This property has a number of TPO trees dotting its western perimeter to the back,
